Management  
Asbestos Survey Report

Kennet Centre, Market Street, Newbury,  
Berkshire, RG14 5EN

139 Bartholomew Street

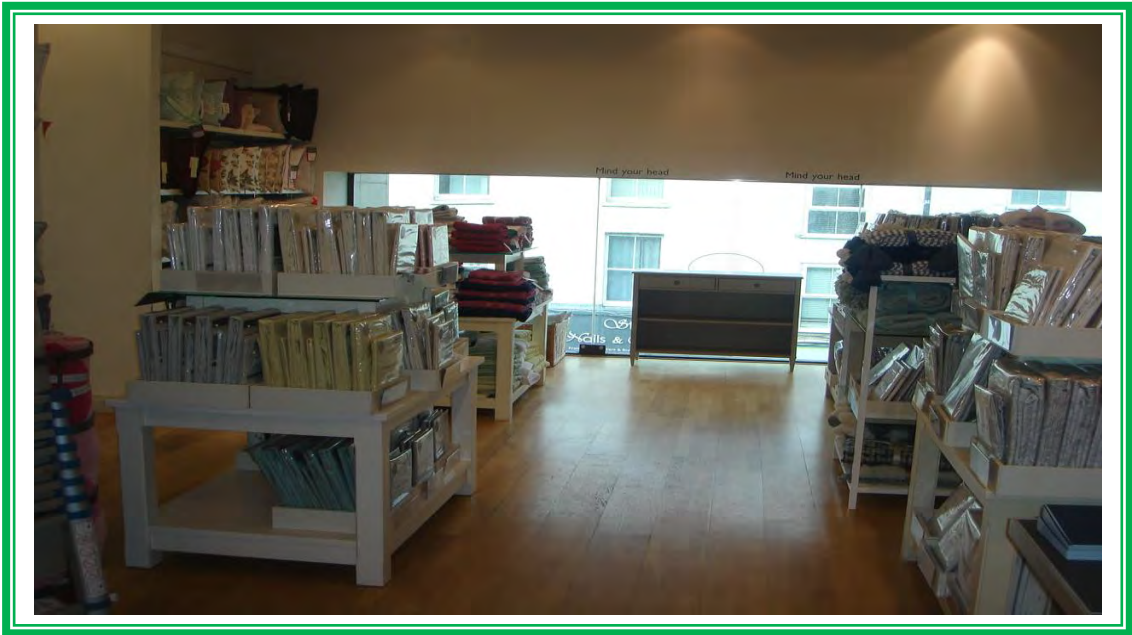
Item No: 1	Sample No: N/A
Location: 1/001 Shop Floor

Material Description:	Visual Inspection – No Suspect Materials Found	
Identification:	N/A	
Approx. quantity:	N/A	
Accessibility	N/A	Assessment Score
Product type:	N/A	N/A
Extent of Damage:	N/A	N/A
Surface Treatment:	N/A	N/A
Asbestos type:	N/A	N/A
Material Assessment Score:		N/A
Priority Assessment Score:		N/A
Action:	N/A	
Comments:	N/A

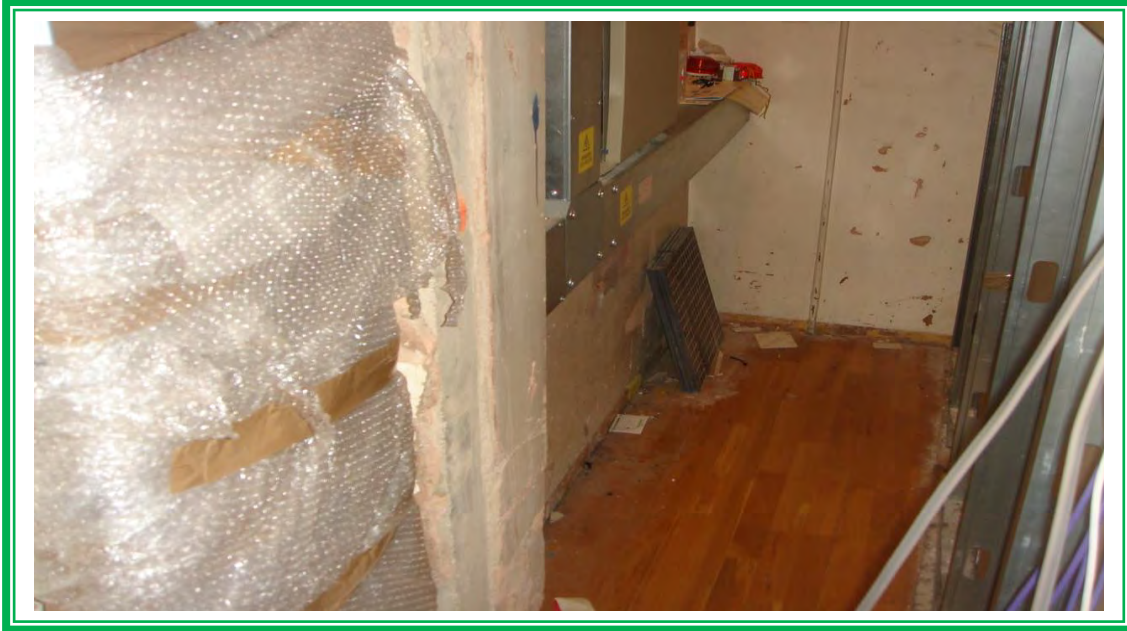
Location: 1/001A Electrics Cupboard

Material Description:	Visual Inspection – No Suspect Materials Found	
Identification:	N/A	
Approx. quantity:	N/A	
Accessibility	N/A	Assessment Score
Product type:	N/A	N/A
Extent of Damage:	N/A	N/A
Surface Treatment:	N/A	N/A
Asbestos type:	N/A	N/A
Material Assessment Score:		N/A
Priority Assessment Score:		N/A
Action:	N/A	
Comments:	N/A

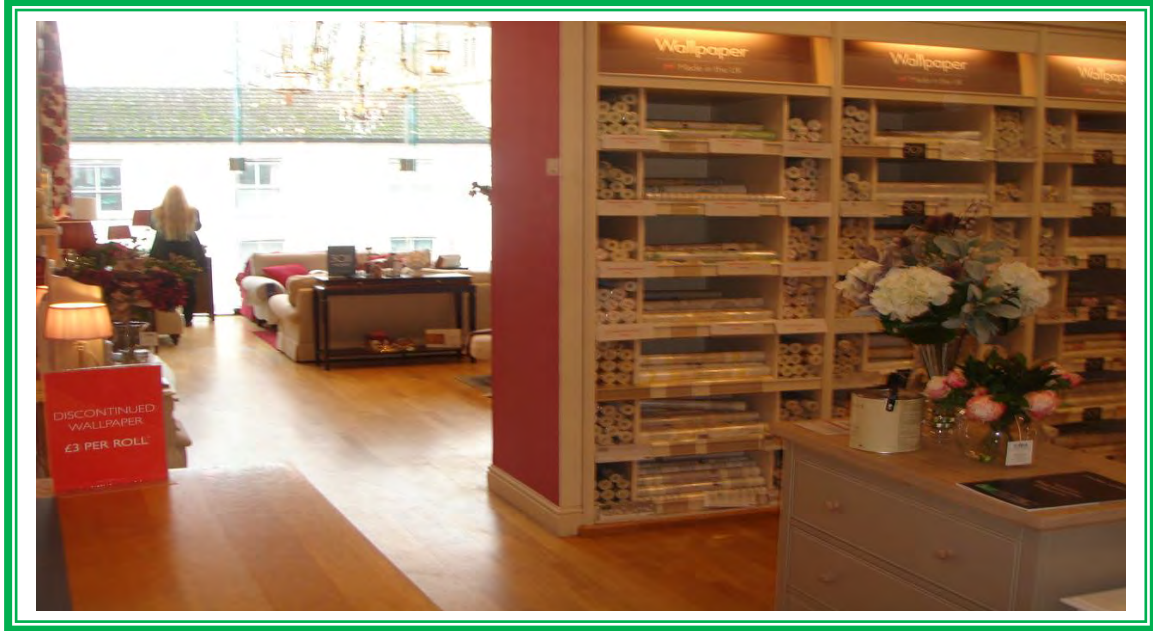
Location: 1/002 Shop Floor

Material Description:	Visual Inspection – No Suspect Materials Found	
Identification:	N/A	
Approx. quantity:	N/A	
Accessibility	N/A	Assessment Score
Product type:	N/A	N/A
Extent of Damage:	N/A	N/A
Surface Treatment:	N/A	N/A
Asbestos type:	N/A	N/A
Material Assessment Score:		N/A
Priority Assessment Score:		N/A
Action:	N/A	
Comments:	N/A

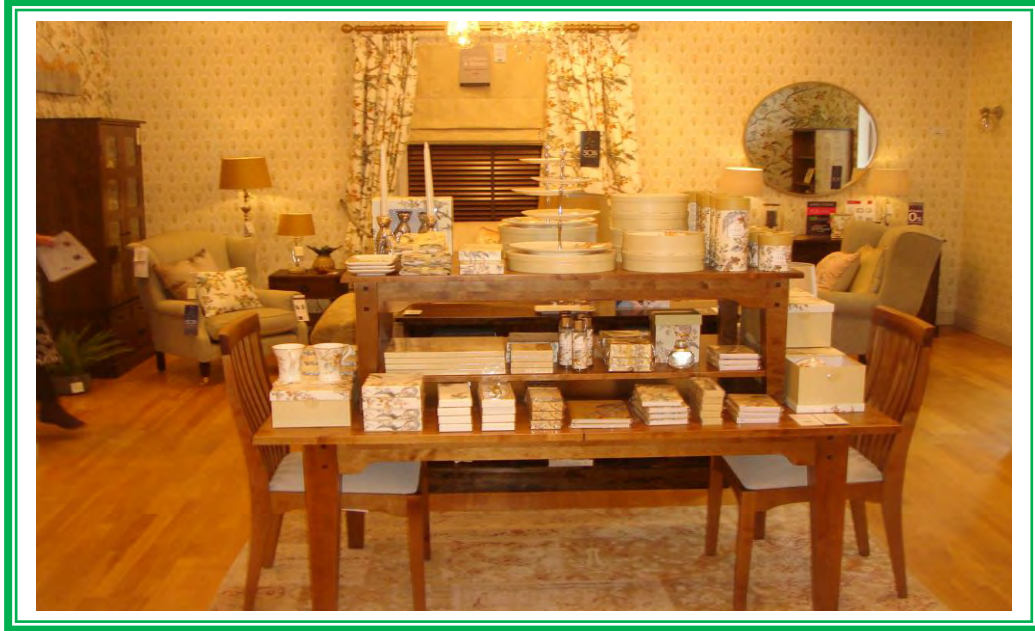
Location: 1/003 Shop Floor

Material Description:	Visual Inspection – No Suspect Materials Found	
Identification:	N/A	
Approx. quantity:	N/A	
Accessibility	N/A	Assessment Score
Product type:	N/A	N/A
Extent of Damage:	N/A	N/A
Surface Treatment:	N/A	N/A
Asbestos type:	N/A	N/A
Material Assessment Score:		N/A
Priority Assessment Score:		N/A
Action:	N/A	
Comments:	N/A

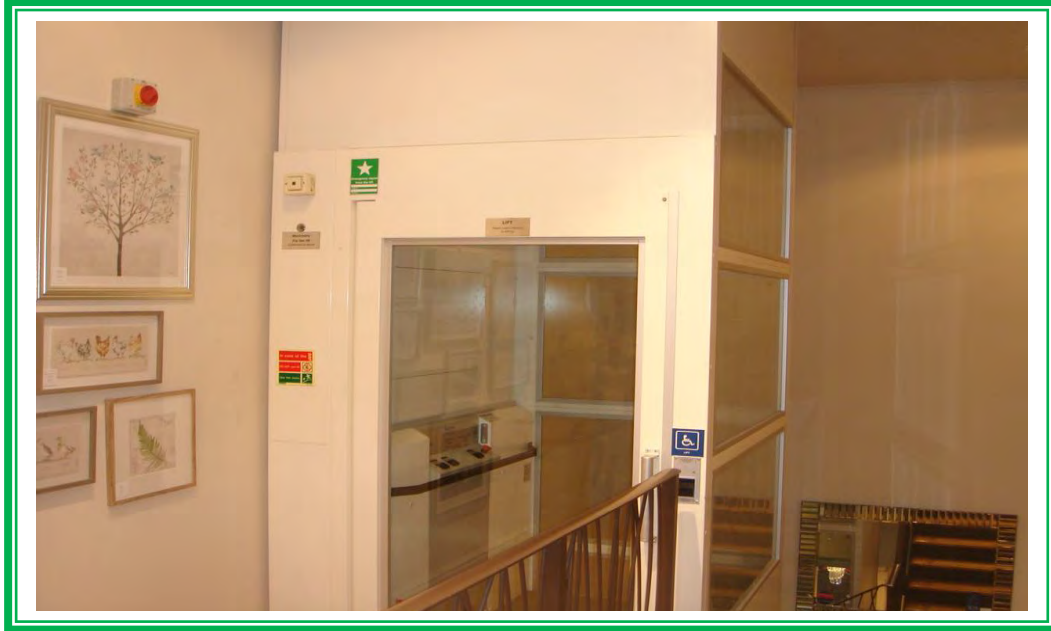
Location: 1/004 Lift

Material Description:	Visual Inspection – No Suspect Materials Found	
Identification:	N/A	
Approx. quantity:	N/A	
Accessibility	N/A	<i>Assessment Score</i>
Product type:	N/A	N/A
Extent of Damage:	N/A	N/A
Surface Treatment:	N/A	N/A
Asbestos type:	N/A	N/A
Material Assessment Score:		N/A
Priority Assessment Score:		N/A
Action:	N/A	
Comments:	N/A

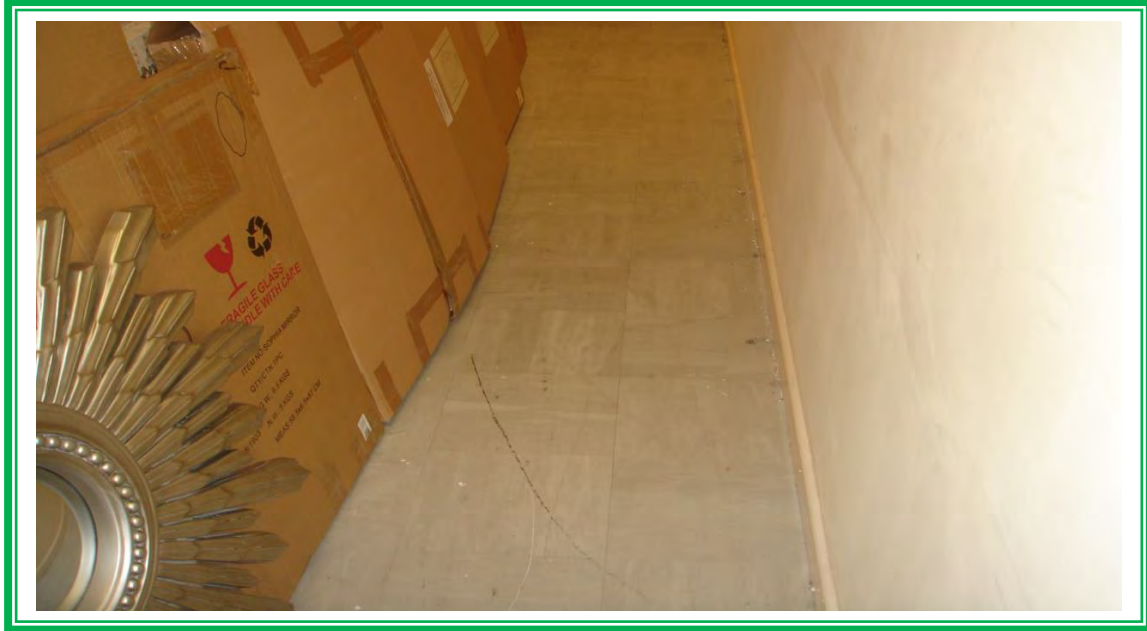
Material Description:	Vinyl Floor Tiles	
Identification:	Sampled - No Asbestos Detected	
Approx. quantity:	6M2	
Accessibility	N/A	Assessment Score
Product type:	N/A	N/A
Extent of Damage:	N/A	N/A
Surface Treatment:	N/A	N/A
Asbestos type:	N/A	N/A
Material Assessment Score:		N/A
Priority Assessment Score:		N/A
Action:	N/A	
Comments:	N/A

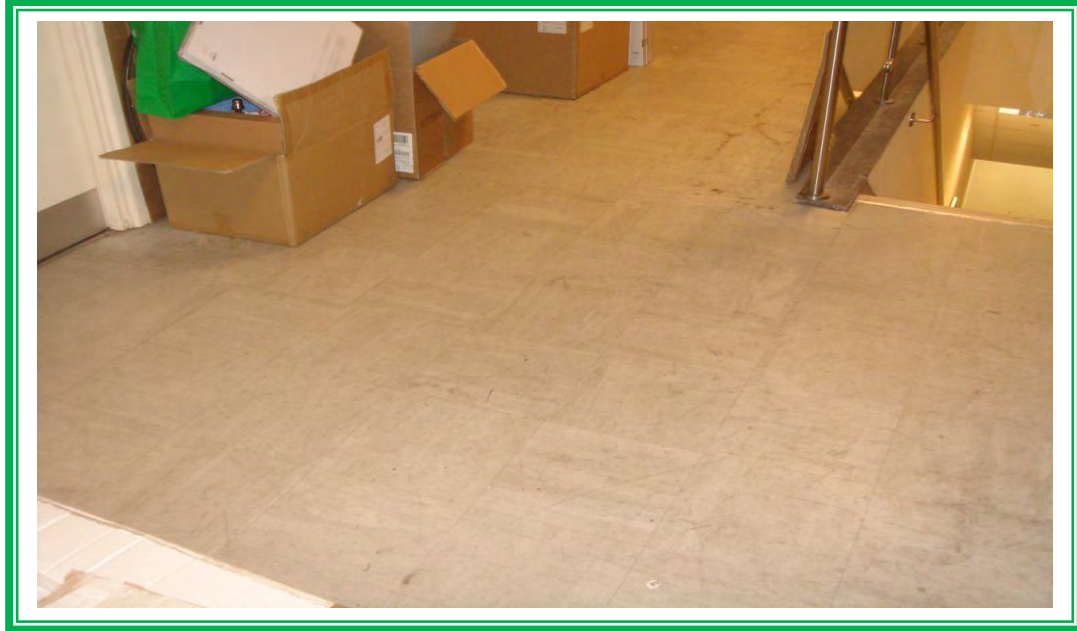
Material Description:	Vinyl Floor Tiles	
Identification:	As Per Sample NE/1 – No Asbestos Detected	
Approx. quantity:	40M2	
Accessibility	N/A	Assessment Score
Product type:	N/A	N/A
Extent of Damage:	N/A	N/A
Surface Treatment:	N/A	N/A
Asbestos type:	N/A	N/A
Material Assessment Score:		N/A
Priority Assessment Score:		N/A
Action:	N/A	
Comments:	N/A

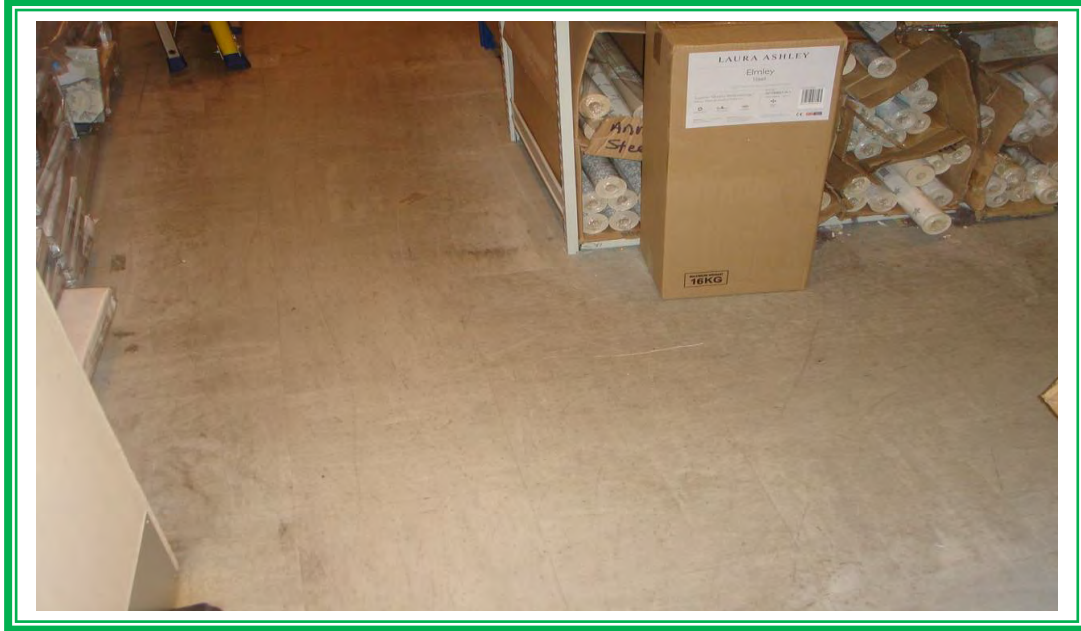
Material Description:	Vinyl Floor Tiles	
Identification:	As Per Sample NE/1 – No Asbestos Detected	
Approx. quantity:	30M2	
Accessibility	N/A	Assessment Score
Product type:	N/A	N/A
Extent of Damage:	N/A	N/A
Surface Treatment:	N/A	N/A
Asbestos type:	N/A	N/A
Material Assessment Score:		N/A
Priority Assessment Score:		N/A
Action:	N/A	
Comments:	N/A

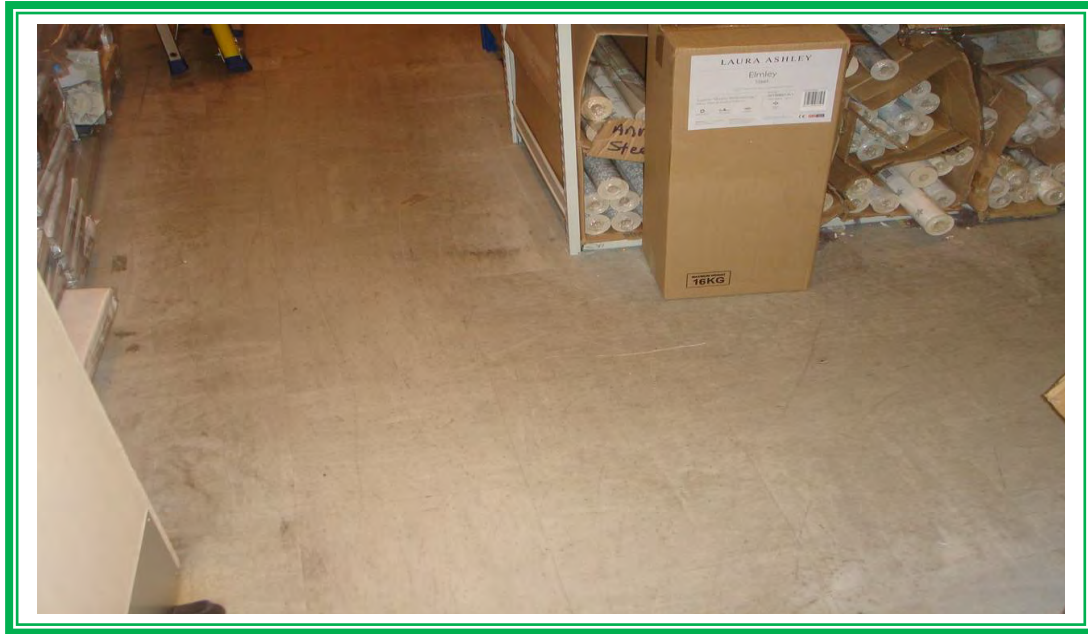
Location: 1/009 Office

Material Description:	Visual Inspection – No Suspect Materials Found	
Identification:	N/A	
Approx. quantity:	N/A	
Accessibility	N/A	Assessment Score
Product type:	N/A	N/A
Extent of Damage:	N/A	N/A
Surface Treatment:	N/A	N/A
Asbestos type:	N/A	N/A
Material Assessment Score:		N/A
Priority Assessment Score:		N/A
Action:	N/A	
Comments:	N/A

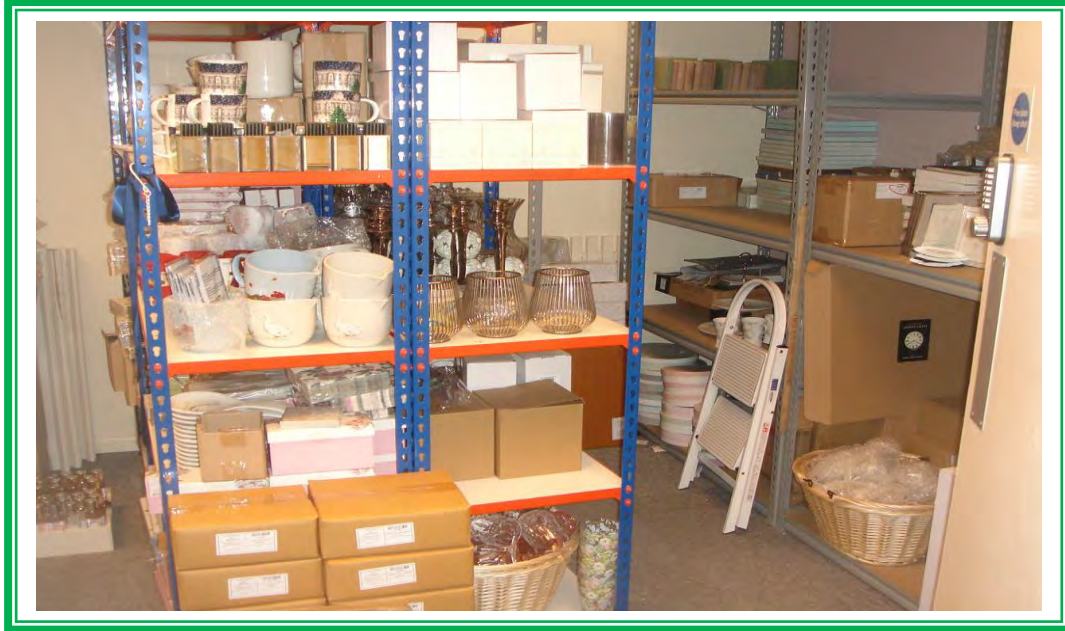
Location: 1/010 Store

Material Description:	Visual Inspection – No Suspect Materials Found	
Identification:	N/A	
Approx. quantity:	N/A	
Accessibility	N/A	Assessment Score
Product type:	N/A	N/A
Extent of Damage:	N/A	N/A
Surface Treatment:	N/A	N/A
Asbestos type:	N/A	N/A
Material Assessment Score:		N/A
Priority Assessment Score:		N/A
Action:	N/A	
Comments:	N/A

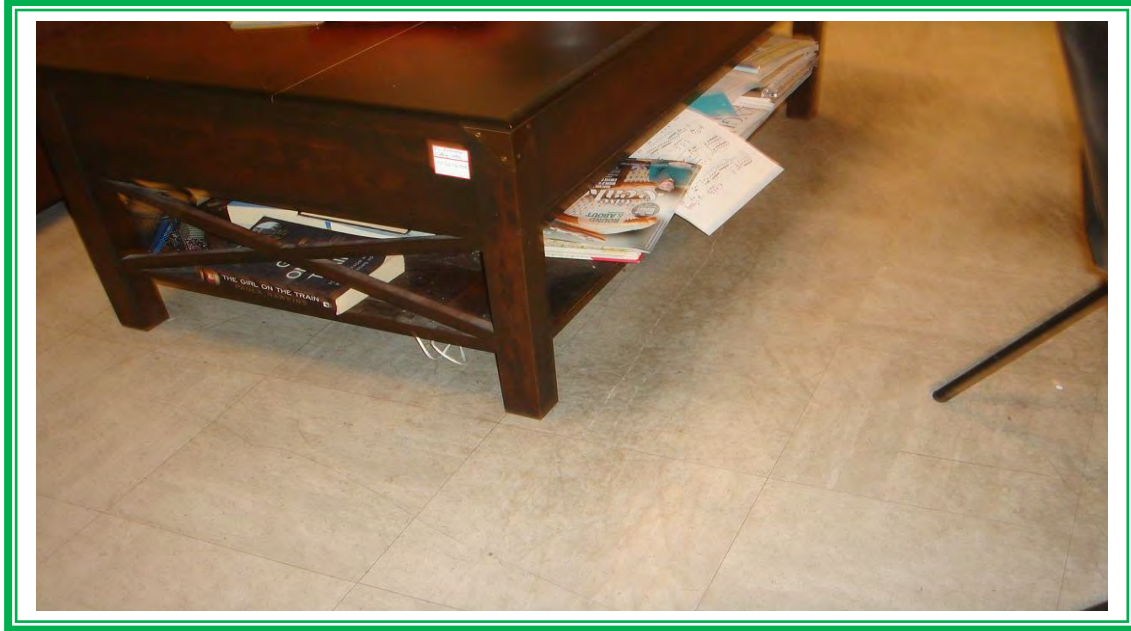
Material Description:	Vinyl Floor Tiles	
Identification:	Sampled - No Asbestos Detected	
Approx. quantity:	16M2	
Accessibility	N/A	Assessment Score
Product type:	N/A	N/A
Extent of Damage:	N/A	N/A
Surface Treatment:	N/A	N/A
Asbestos type:	N/A	N/A
Material Assessment Score:		N/A
Priority Assessment Score:		N/A
Action:	N/A	
Comments:	N/A

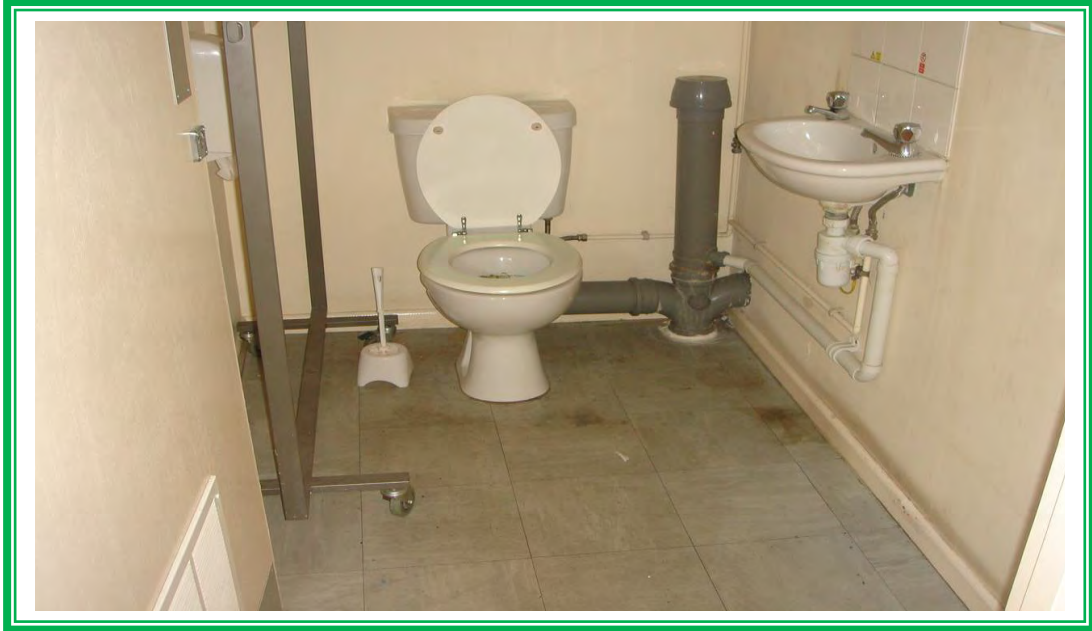
Material Description:	Vinyl Floor Tiles	
Identification:	As Per Sample NE/2 – No Asbestos Detected	
Approx. quantity:	3M2	
Accessibility	N/A	Assessment Score
Product type:	N/A	N/A
Extent of Damage:	N/A	N/A
Surface Treatment:	N/A	N/A
Asbestos type:	N/A	N/A
Material Assessment Score:		N/A
Priority Assessment Score:		N/A
Action:	N/A	
Comments:	N/A

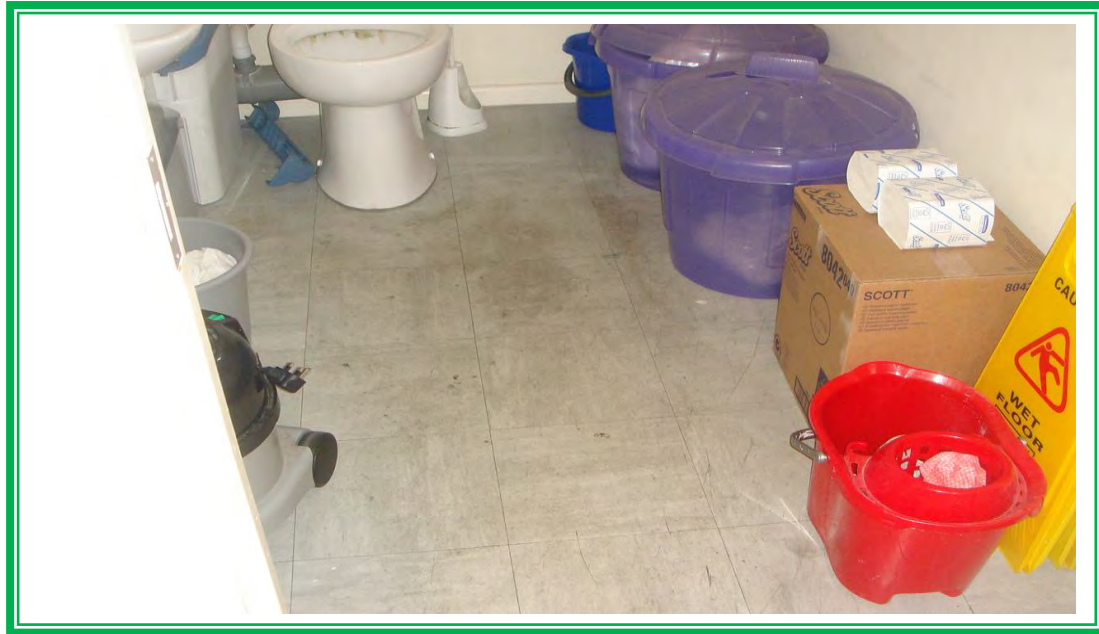
Material Description:	Vinyl Floor Tiles	
Identification:	As Per Sample NE/2 – No Asbestos Detected	
Approx. quantity:	3M2	
Accessibility	N/A	Assessment Score
Product type:	N/A	N/A
Extent of Damage:	N/A	N/A
Surface Treatment:	N/A	N/A
Asbestos type:	N/A	N/A
Material Assessment Score:		N/A
Priority Assessment Score:		N/A
Action:	N/A	
Comments:	N/A

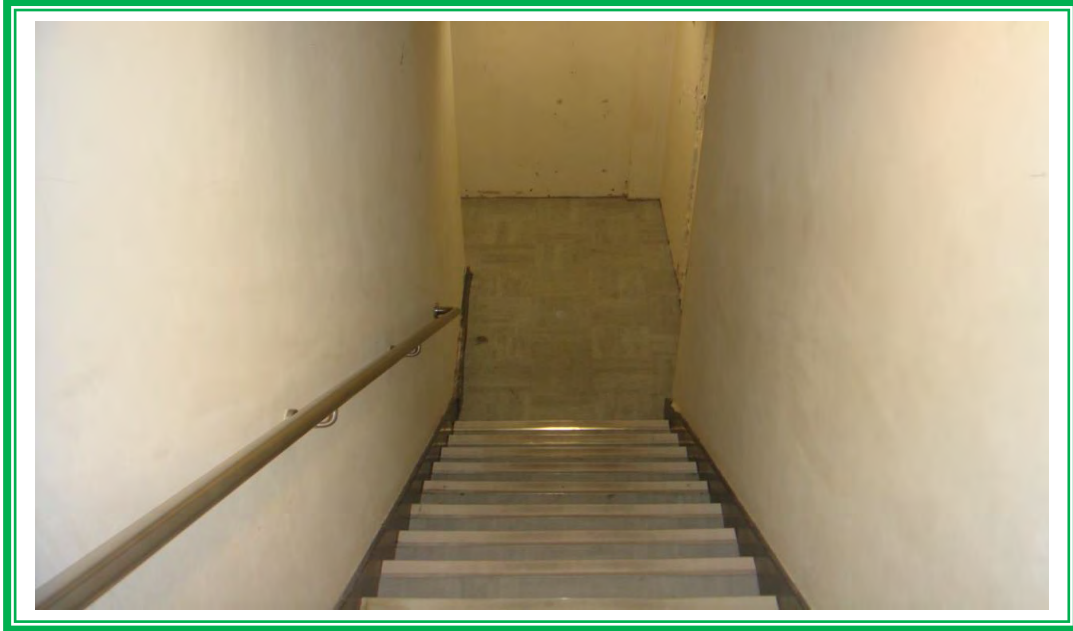
Material Description:	Vinyl Floor Tiles	
Identification:	As Per Sample NE/2 – No Asbestos Detected	
Approx. quantity:	20M2	
Accessibility	N/A	Assessment Score
Product type:	N/A	N/A
Extent of Damage:	N/A	N/A
Surface Treatment:	N/A	N/A
Asbestos type:	N/A	N/A
Material Assessment Score:		N/A
Priority Assessment Score:		N/A
Action:	N/A	
Comments:	N/A

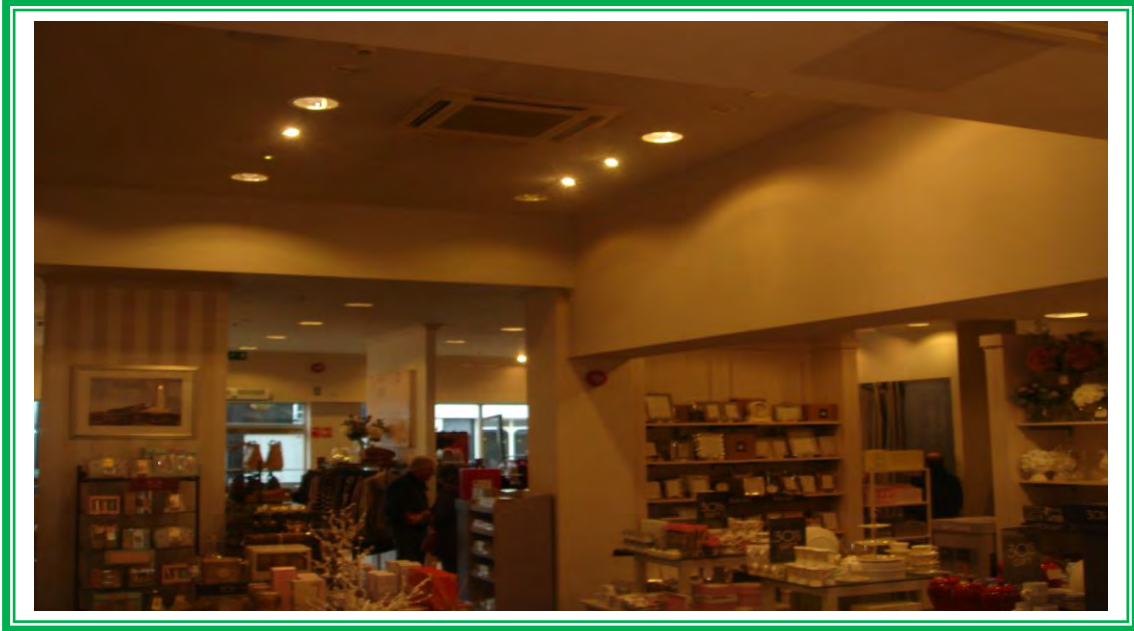
Location: 0/001 Shop Floor

Material Description:	Visual Inspection – No Suspect Materials Found	
Identification:	N/A	
Approx. quantity:	N/A	
Accessibility	N/A	Assessment Score
Product type:	N/A	N/A
Extent of Damage:	N/A	N/A
Surface Treatment:	N/A	N/A
Asbestos type:	N/A	N/A
Material Assessment Score:		N/A
Priority Assessment Score:		N/A
Action:	N/A	
Comments:	N/A

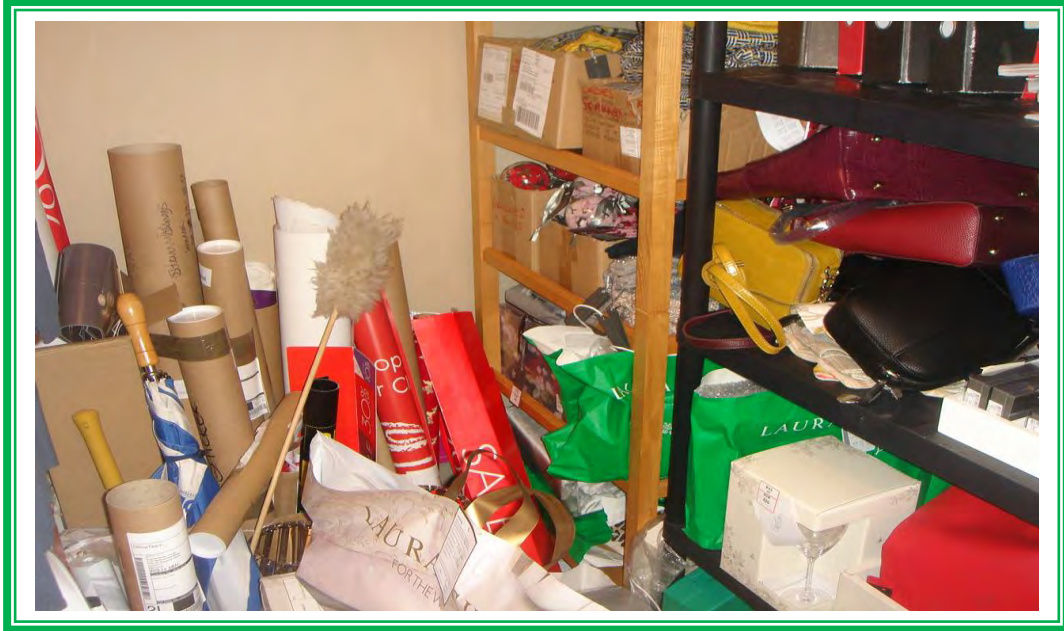
Location: 0/002 Cupboard

Material Description:	Visual Inspection – No Suspect Materials Found	
Identification:	N/A	
Approx. quantity:	N/A	
Accessibility	N/A	Assessment Score
Product type:	N/A	N/A
Extent of Damage:	N/A	N/A
Surface Treatment:	N/A	N/A
Asbestos type:	N/A	N/A
Material Assessment Score:		N/A
Priority Assessment Score:		N/A
Action:	N/A	
Comments:	N/A

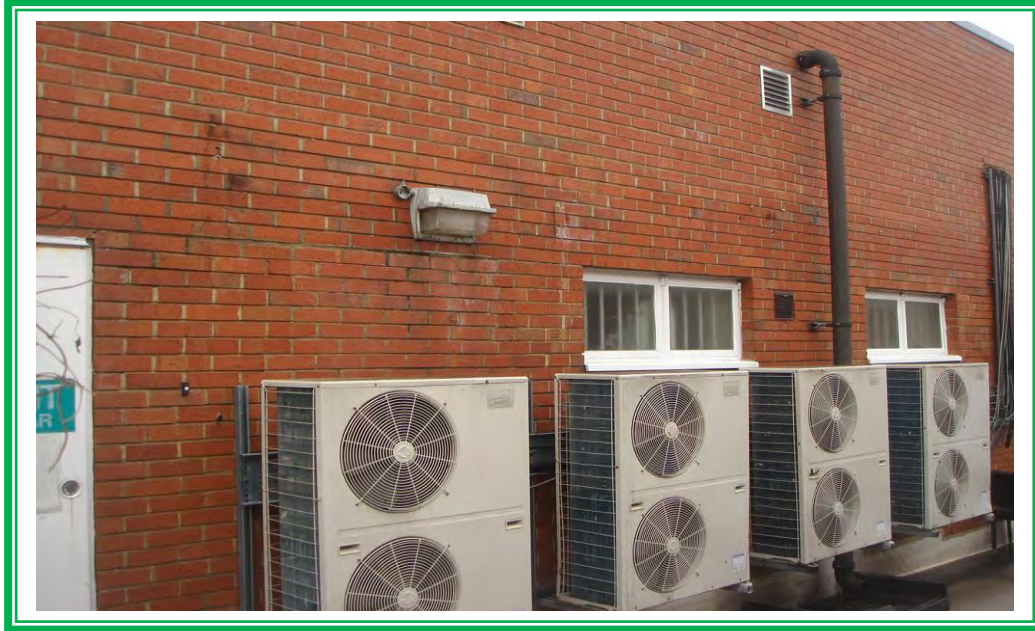
Location: 99/001 External

Material Description:	Visual Inspection – No Suspect Materials Found	
Identification:	N/A	
Approx. quantity:	N/A	
Accessibility	N/A	Assessment Score
Product type:	N/A	N/A
Extent of Damage:	N/A	N/A
Surface Treatment:	N/A	N/A
Asbestos type:	N/A	N/A
Material Assessment Score:		N/A
Priority Assessment Score:		N/A
Action:	N/A	
Comments:	N/A

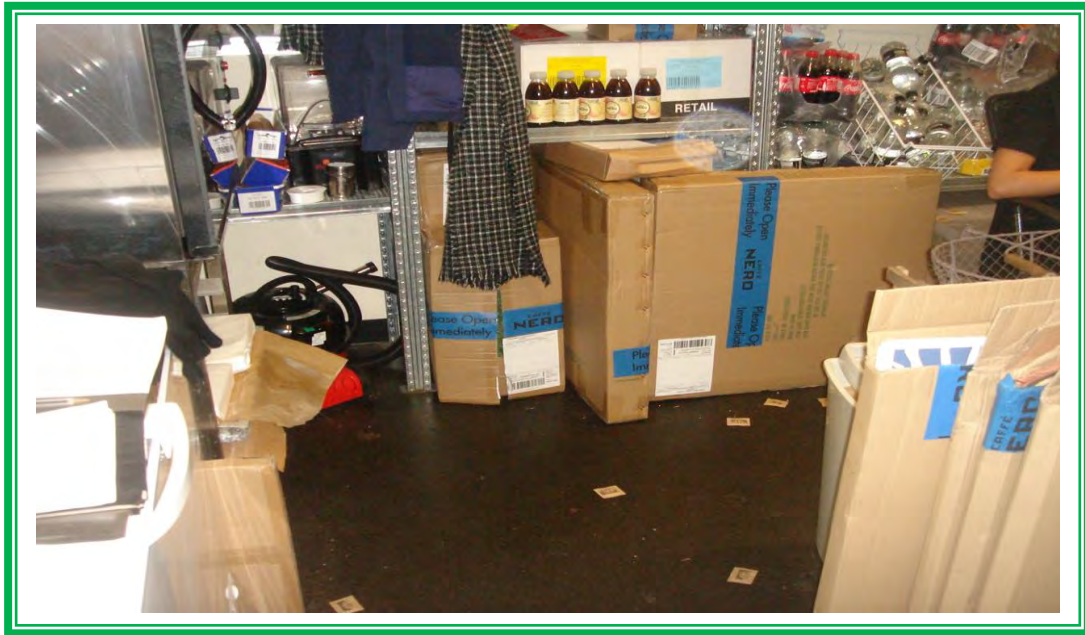
Item No: 1	Sample No: N/A
Location: 0/001 Store

Material Description:	Visual Inspection – No Suspect Materials Found	
Identification:	N/A	
Approx. quantity:	N/A	
Accessibility	N/A	Assessment Score
Product type:	N/A	N/A
Extent of Damage:	N/A	N/A
Surface Treatment:	N/A	N/A
Asbestos type:	N/A	N/A
Material Assessment Score:		N/A
Priority Assessment Score:		N/A
Action:	N/A	
Comments:	N/A

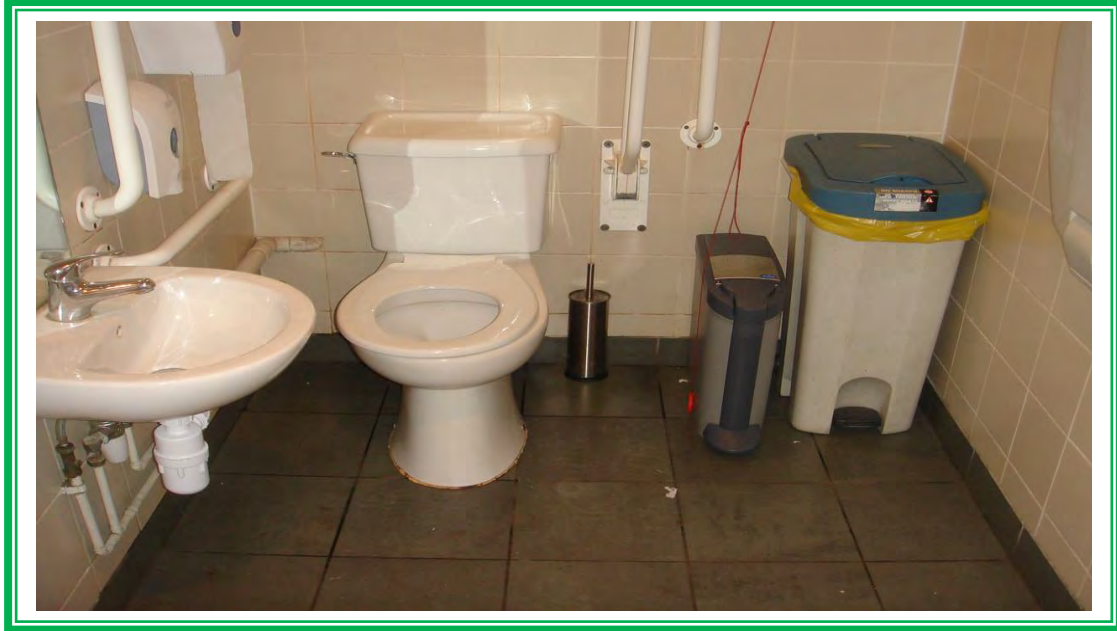
Location: 0/002 WC

Material Description:	Visual Inspection – No Suspect Materials Found	
Identification:	N/A	
Approx. quantity:	N/A	
Accessibility	N/A	Assessment Score
Product type:	N/A	N/A
Extent of Damage:	N/A	N/A
Surface Treatment:	N/A	N/A
Asbestos type:	N/A	N/A
Material Assessment Score:		N/A
Priority Assessment Score:		N/A
Action:	N/A	
Comments:	N/A

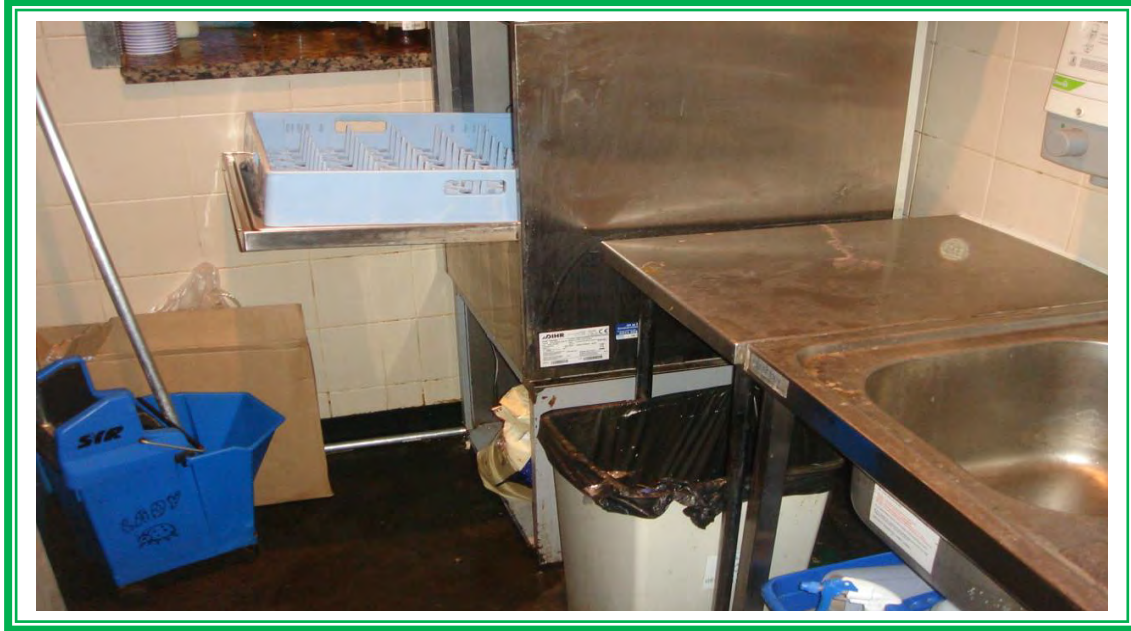
Location: 0/003

Material Description:	Visual Inspection – No Suspect Materials Found	
Identification:	N/A	
Approx. quantity:	N/A	
Accessibility	N/A	Assessment Score
Product type:	N/A	N/A
Extent of Damage:	N/A	N/A
Surface Treatment:	N/A	N/A
Asbestos type:	N/A	N/A
Material Assessment Score:		N/A
Priority Assessment Score:		N/A
Action:	N/A	
Comments:	N/A

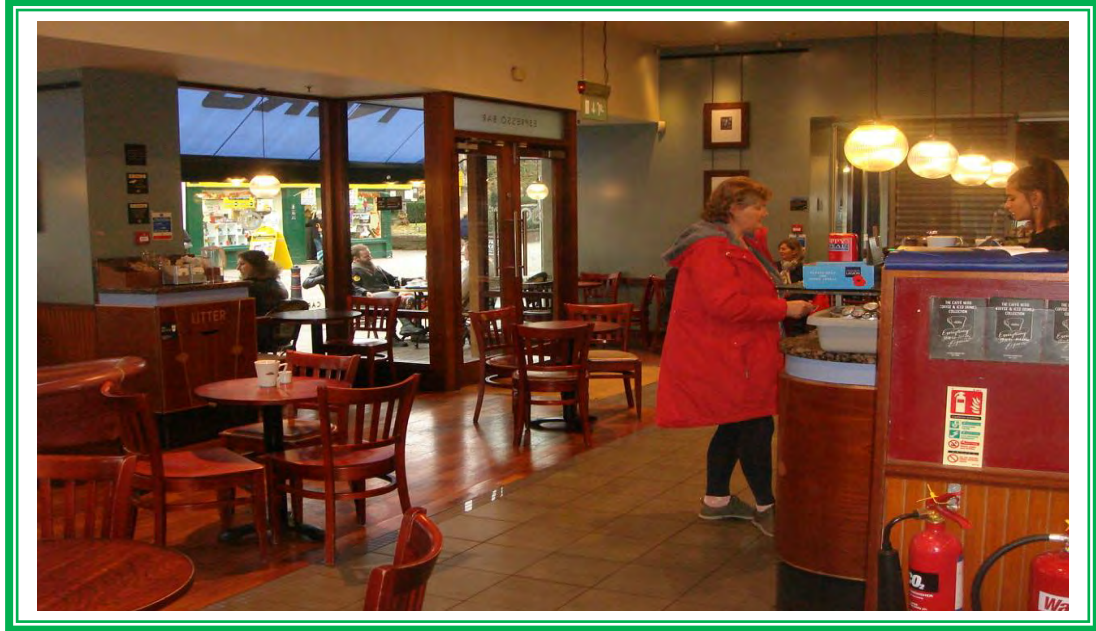
Location: 0/004

Material Description:	Visual Inspection – No Suspect Materials Found	
Identification:	N/A	
Approx. quantity:	N/A	
Accessibility	N/A	Assessment Score
Product type:	N/A	N/A
Extent of Damage:	N/A	N/A
Surface Treatment:	N/A	N/A
Asbestos type:	N/A	N/A
Material Assessment Score:		N/A
Priority Assessment Score:		N/A
Action:	N/A	
Comments:	N/A

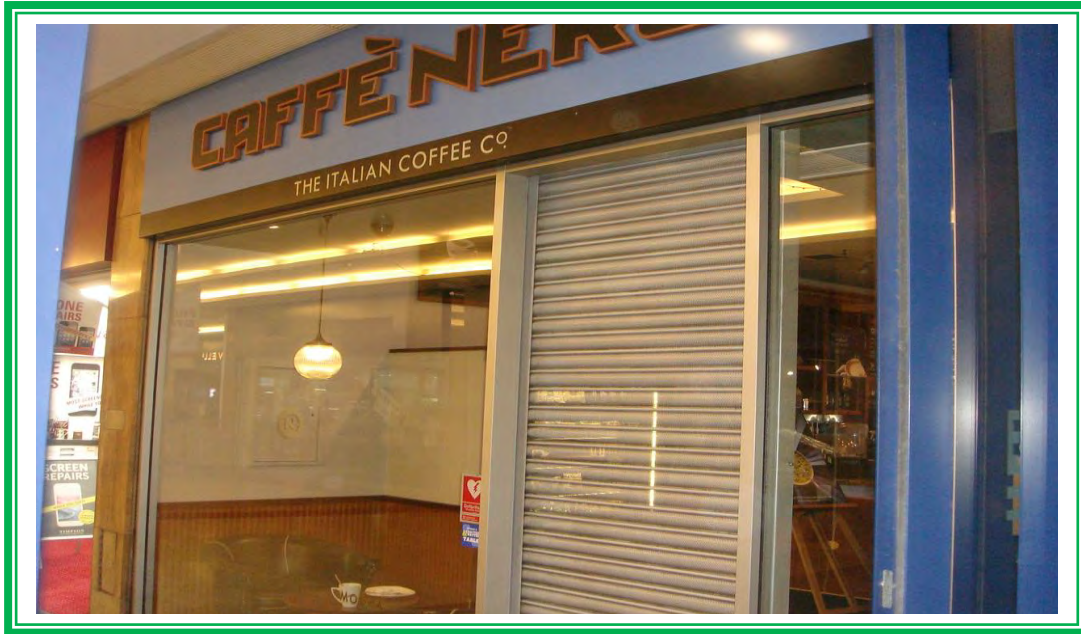
Location: 99/001 Externals

Material Description:	Visual Inspection – No Suspect Materials Found	
Identification:	N/A	
Approx. quantity:	N/A	
Accessibility	N/A	Assessment Score
Product type:	N/A	N/A
Extent of Damage:	N/A	N/A
Surface Treatment:	N/A	N/A
Asbestos type:	N/A	N/A
Material Assessment Score:		N/A
Priority Assessment Score:		N/A
Action:	N/A	
Comments:	N/A

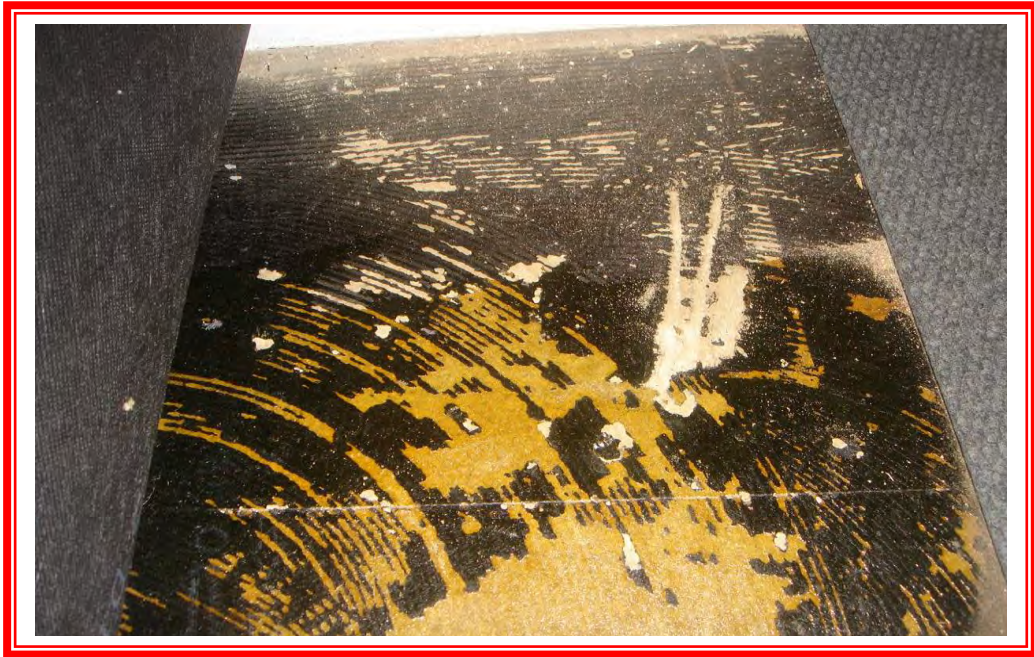
Material Description:	Bitumen Adhesive Floor	
Identification:	Sampled – Asbestos Detected	
Approx. quantity:	20M2	
Accessibility	Low	Assessment Score
Product type:	Bitumen	1
Extent of Damage:	Minor	1
Surface Treatment:	Non-Friable	0
Asbestos type:	Chrysotile	1
Material Assessment Score:		3
Priority Assessment Score:		Negligible
Action:	Manage	
Comments:	N/A

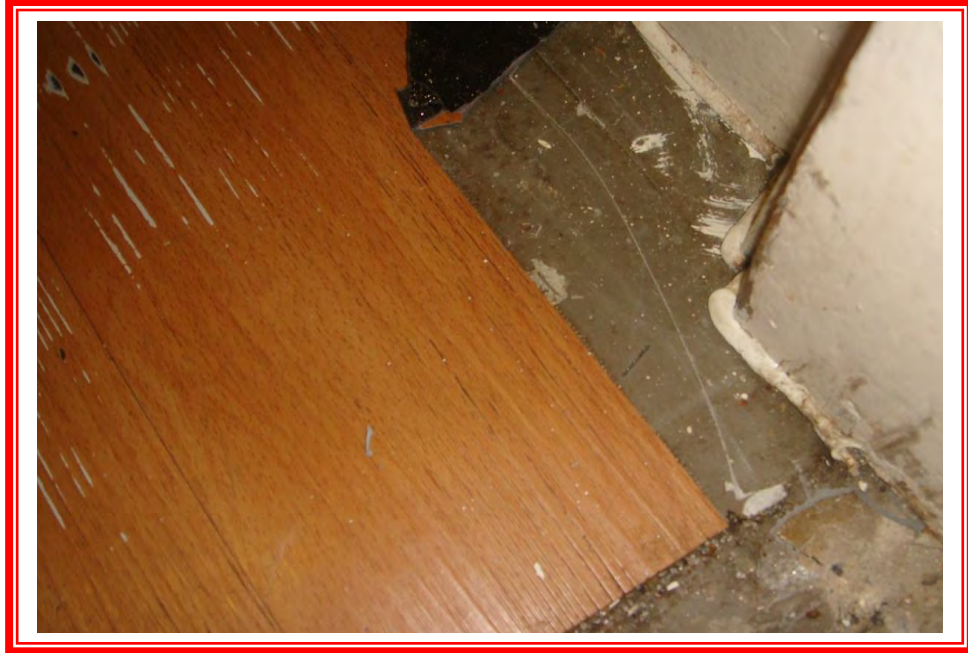
Material Description:	Vinyl Floor Tiles	
Identification:	Sampled - Asbestos Detected	
Approx. quantity:	2M2	
Accessibility	Low	Assessment Score
Product type:	Vinyl	1
Extent of Damage:	Minor	1
Surface Treatment:	Non-Friable	0
Asbestos type:	Chrysotile	1
Material Assessment Score:		3
Priority Assessment Score:		Negligible
Action:	Manage	
Comments:	N/A

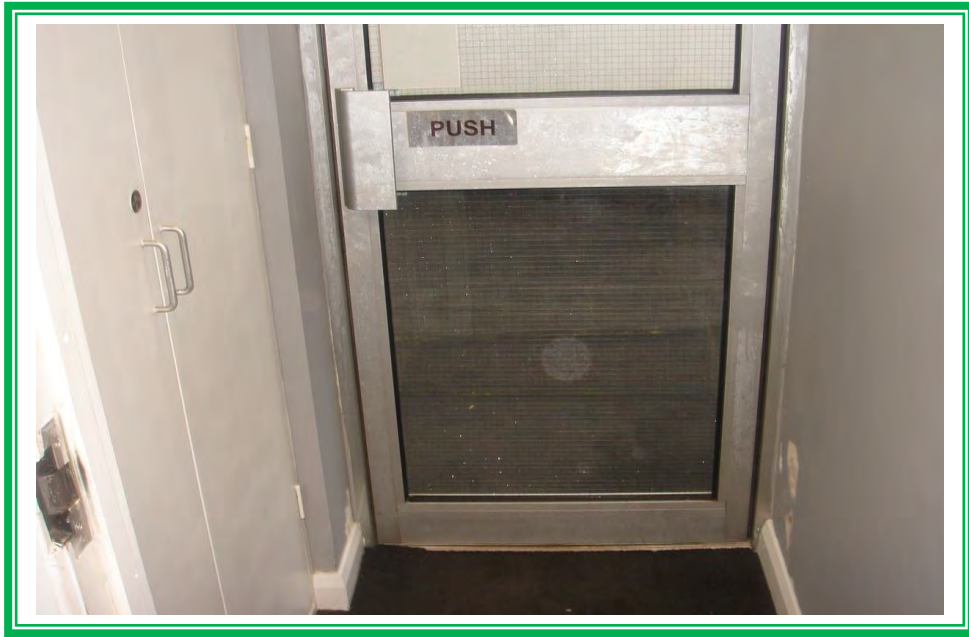
Item No: 1	Sample No: N/A
Location: 0/001 – Entrance

Material Description:	Visual Inspection – No Suspect Materials Found	
Identification:	N/A	
Approx. quantity:	N/A	
Accessibility	N/A	Assessment Score
Product type:	N/A	N/A
Extent of Damage:	N/A	N/A
Surface Treatment:	N/A	N/A
Asbestos type:	N/A	N/A
Material Assessment Score:		N/A
Priority Assessment Score:		N/A
Action:	N/A	
Comments:	N/A

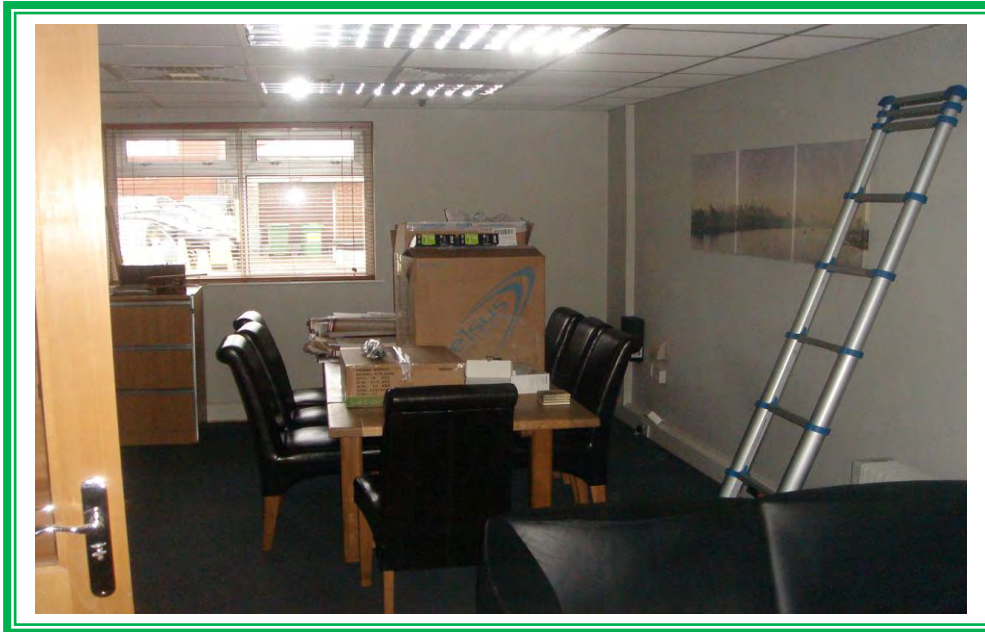
Location: 0/003 – Office

Material Description:	Visual Inspection – No Suspect Materials Found	
Identification:	N/A	
Approx. quantity:	N/A	
Accessibility	N/A	Assessment Score
Product type:	N/A	N/A
Extent of Damage:	N/A	N/A
Surface Treatment:	N/A	N/A
Asbestos type:	N/A	N/A
Material Assessment Score:		N/A
Priority Assessment Score:		N/A
Action:	N/A	
Comments:	N/A

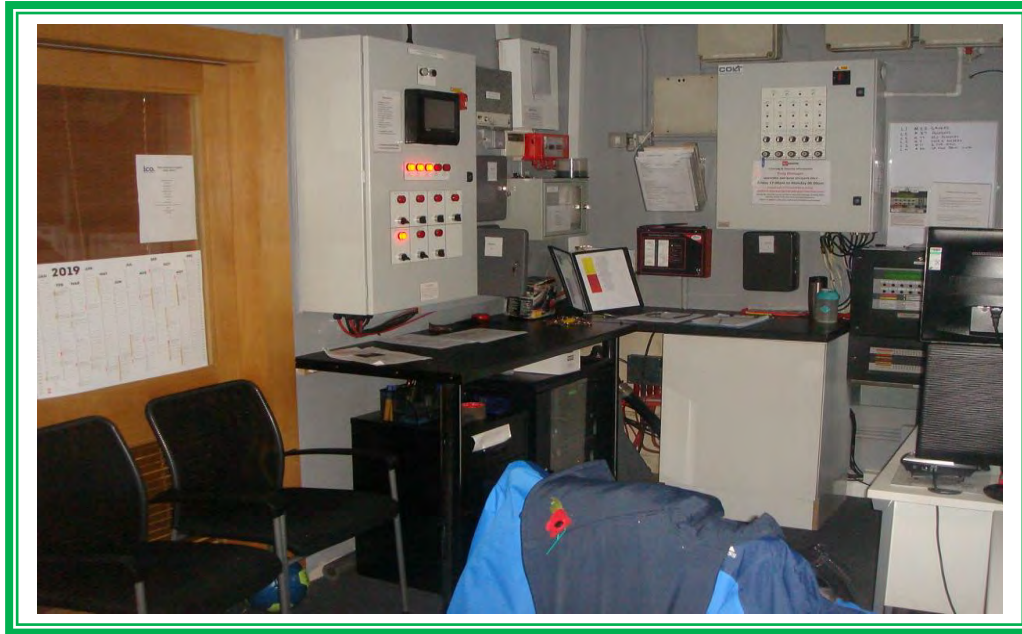
Location: 0/004 – Security Room

Material Description:	Visual Inspection – No Suspect Materials Found	
Identification:	N/A	
Approx. quantity:	N/A	
Accessibility	N/A	Assessment Score
Product type:	N/A	N/A
Extent of Damage:	N/A	N/A
Surface Treatment:	N/A	N/A
Asbestos type:	N/A	N/A
Material Assessment Score:		N/A
Priority Assessment Score:		N/A
Action:	N/A	
Comments:	N/A

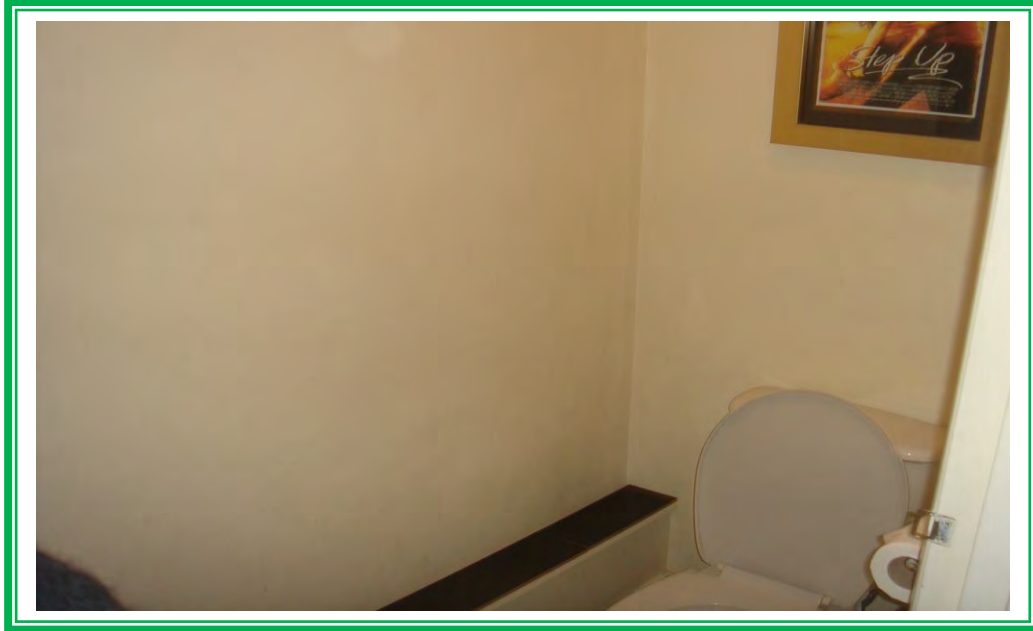
Location: 0/006 - WC

Material Description:	Visual Inspection – No Suspect Materials Found	
Identification:	N/A	
Approx. quantity:	N/A	
Accessibility	N/A	Assessment Score
Product type:	N/A	N/A
Extent of Damage:	N/A	N/A
Surface Treatment:	N/A	N/A
Asbestos type:	N/A	N/A
Material Assessment Score:		N/A
Priority Assessment Score:		N/A
Action:	N/A	
Comments:	N/A

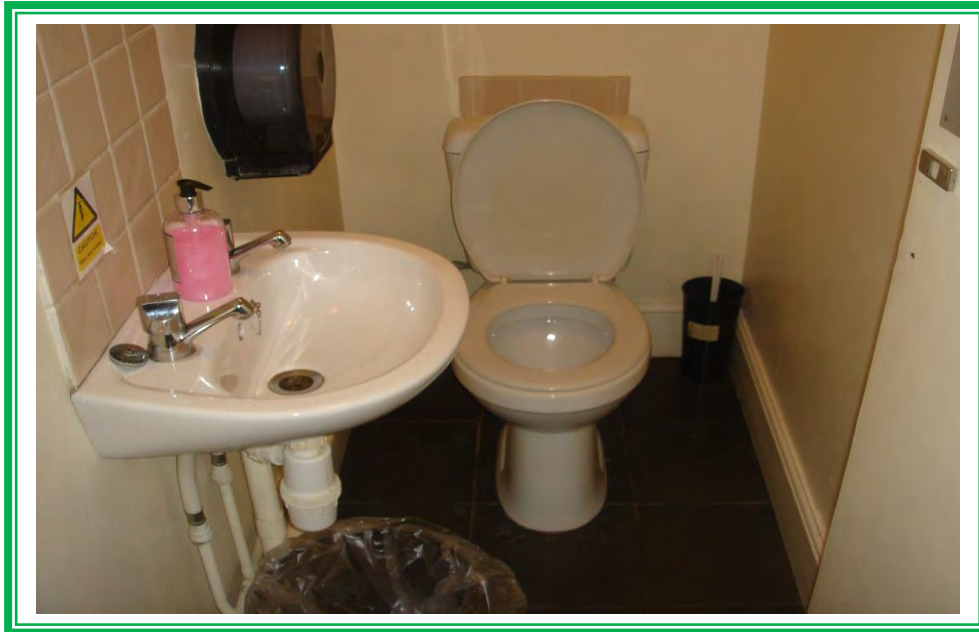
Location: 0/007 - WC

Material Description:	Visual Inspection – No Suspect Materials Found	
Identification:	N/A	
Approx. quantity:	N/A	
Accessibility	N/A	Assessment Score
Product type:	N/A	N/A
Extent of Damage:	N/A	N/A
Surface Treatment:	N/A	N/A
Asbestos type:	N/A	N/A
Material Assessment Score:		N/A
Priority Assessment Score:		N/A
Action:	N/A	
Comments:	N/A
