Management  
Asbestos Survey Report

Kennet Centre, Market Street, Newbury,  
Berkshire, RG14 5EN

139 Bartholomew Street

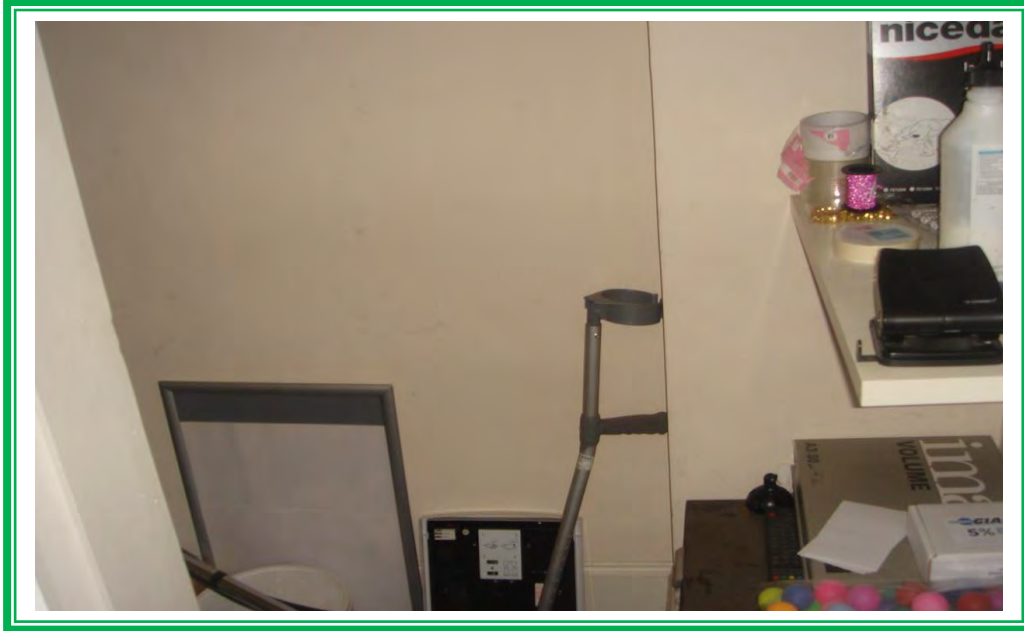
Location: 0/008 – Cupboard

Material Description:	Visual Inspection – No Suspect Materials Found	
Identification:	N/A	
Approx. quantity:	N/A	
Accessibility	N/A	Assessment Score
Product type:	N/A	N/A
Extent of Damage:	N/A	N/A
Surface Treatment:	N/A	N/A
Asbestos type:	N/A	N/A
Material Assessment Score:		N/A
Priority Assessment Score:		N/A
Action:	N/A	
Comments:	N/A

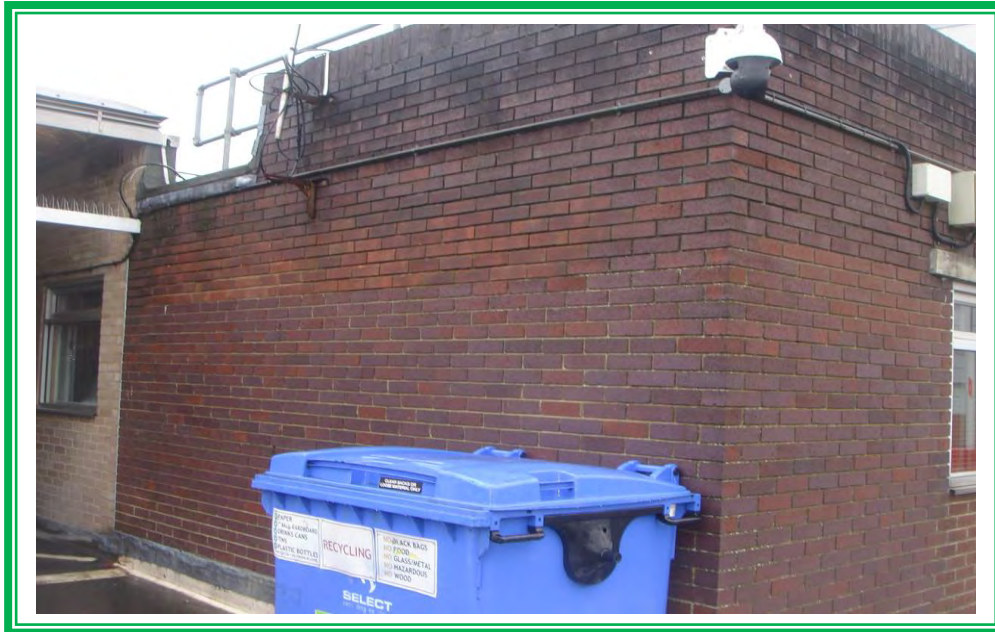
Location: 99/001 – External

Material Description:	Visual Inspection – No Suspect Materials Found	
Identification:	N/A	
Approx. quantity:	N/A	
Accessibility	N/A	<i>Assessment Score</i>
Product type:	N/A	N/A
Extent of Damage:	N/A	N/A
Surface Treatment:	N/A	N/A
Asbestos type:	N/A	N/A
Material Assessment Score:		N/A
Priority Assessment Score:		N/A
Action:	N/A	
Comments:	N/A

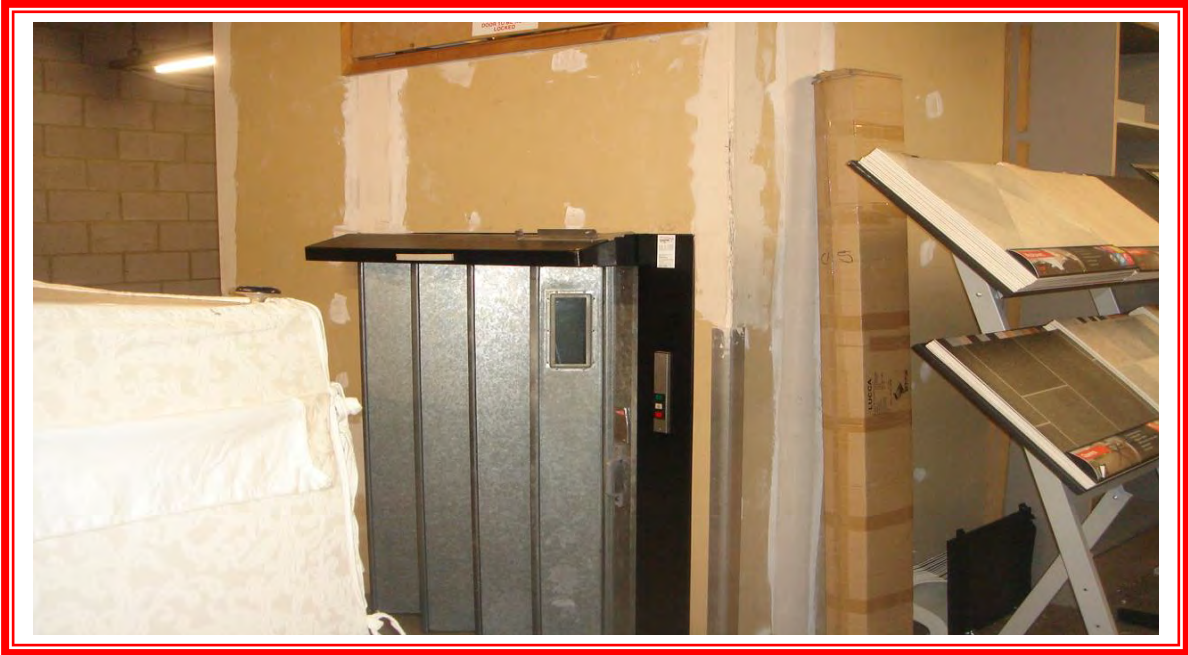
Material Description:	No Access	
Identification:	Presumed to Contain asbestos	
Approx. quantity:	X 1 Lift	
Accessibility	Medium	<i>Assessment Score</i>
Product type:	No Access	3
Extent of Damage:	No Access	3
Surface Treatment:	No Access	3
Asbestos type:	No Access	3
Material Assessment Score:		12
Priority Assessment Score:		High
Action:	Further Inspection Required	
Comments:	Unable to gain access as no lift engineer was onsite

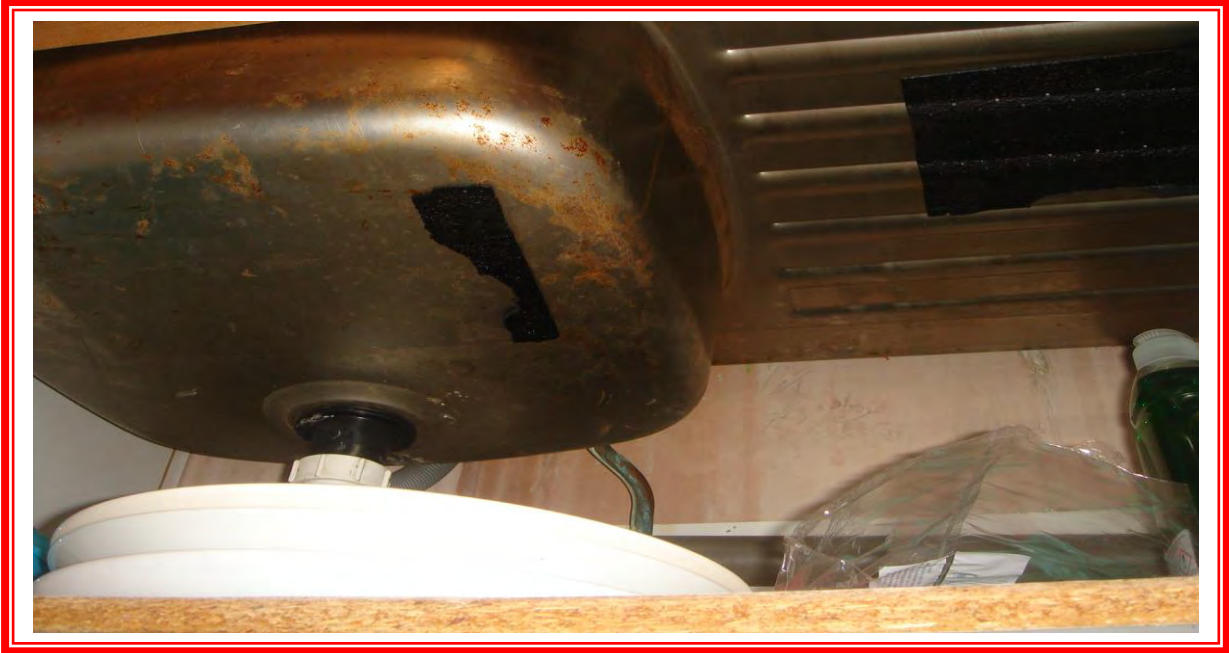
Material Description:	Sink Pad	
Identification:	Sampled - Asbestos Detected	
Approx. quantity:	X 2	
Accessibility	Low	Assessment Score
Product type:	Bitumen	1
Extent of Damage:	Moderate	2
Surface Treatment:	Non-Friable	0
Asbestos type:	Chrysotile	1
Material Assessment Score:		4
Priority Assessment Score:		Negligible
Action:	Manage	
Comments:	N/A

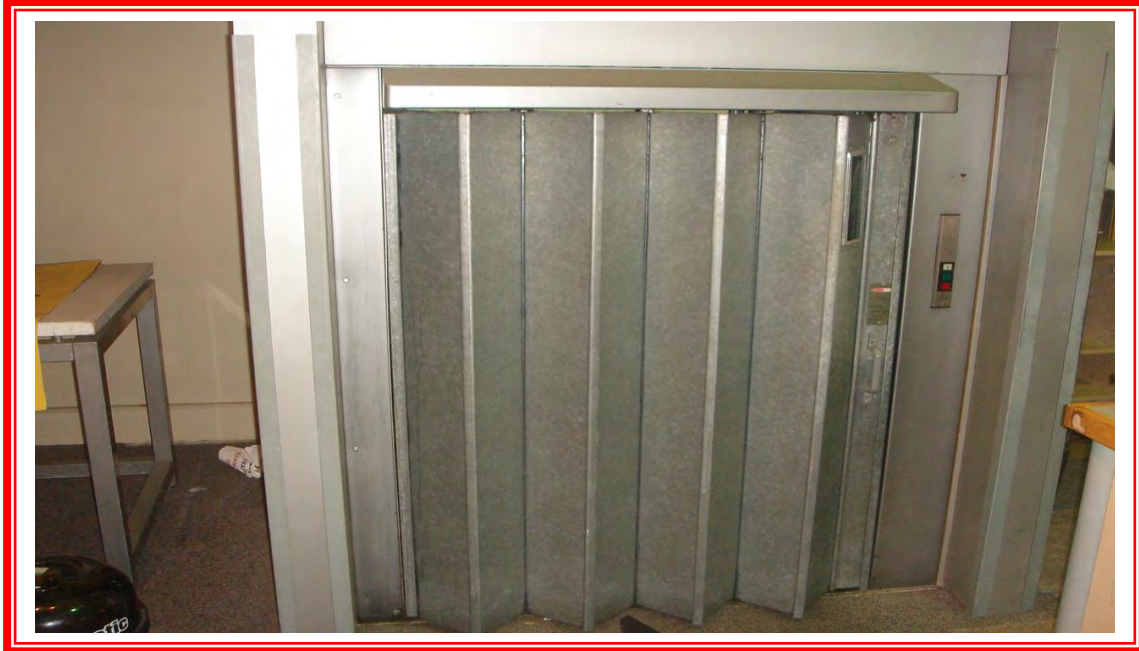
Material Description:	No Access	
Identification:	Presumed to Contain asbestos	
Approx. quantity:	X 1 Lift and Shaft	
Accessibility	Low	Assessment Score
Product type:	No Access	3
Extent of Damage:	No Access	3
Surface Treatment:	No Access	3
Asbestos type:	No Access	3
Material Assessment Score:		12
Priority Assessment Score:		High
Action:	Further Inspection Required	
Comments:	Unable to gain access as no lift engineer was onsite

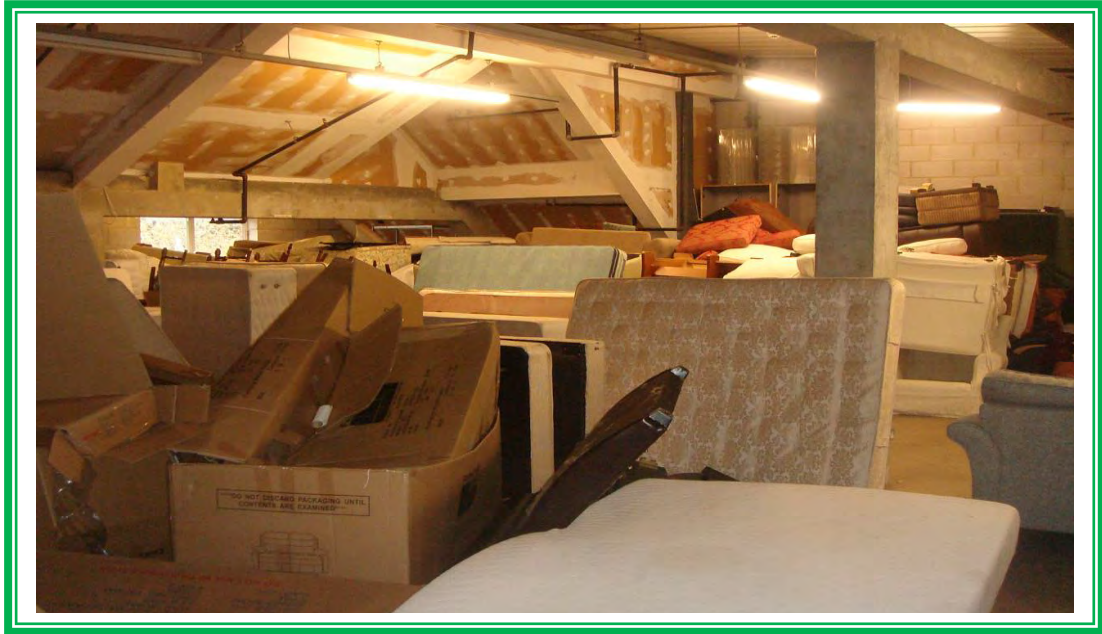
Item No: 1	Sample No: N/A
Location: 1/001 Store

Material Description:	Visual Inspection – No Suspect Materials Found	
Identification:	N/A	
Approx. quantity:	N/A	
Accessibility	N/A	Assessment Score
Product type:	N/A	N/A
Extent of Damage:	N/A	N/A
Surface Treatment:	N/A	N/A
Asbestos type:	N/A	N/A
Material Assessment Score:		N/A
Priority Assessment Score:		N/A
Action:	N/A	
Comments:	N/A

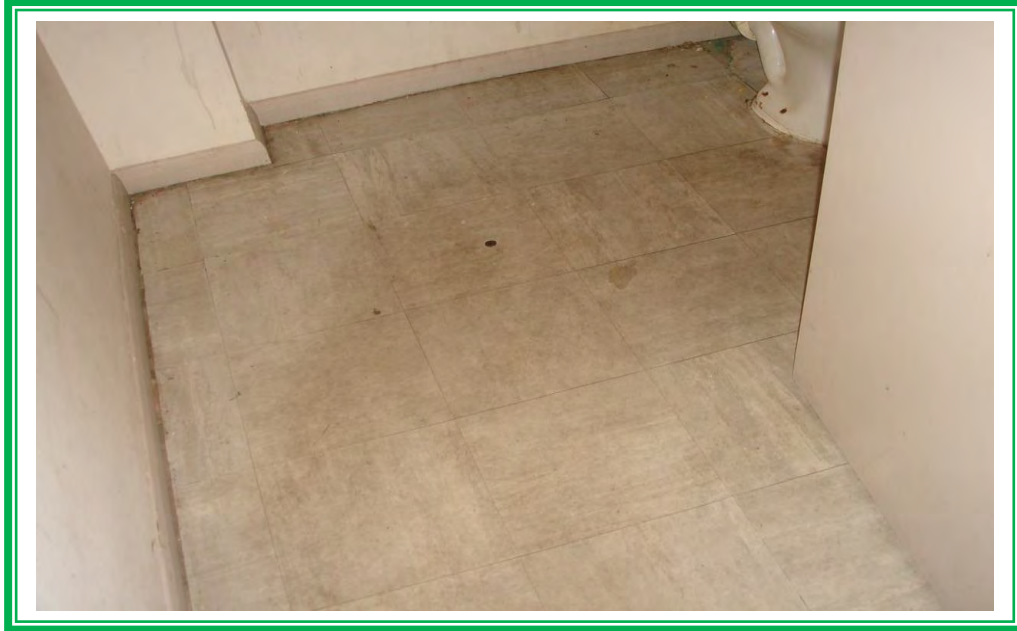
Material Description:	Vinyl Floor Tiles	
Identification:	Sampled - No Asbestos Detected	
Approx. quantity:	4M2	
Accessibility	N/A	Assessment Score
Product type:	N/A	N/A
Extent of Damage:	N/A	N/A
Surface Treatment:	N/A	N/A
Asbestos type:	N/A	N/A
Material Assessment Score:		N/A
Priority Assessment Score:		N/A
Action:	N/A	
Comments:	N/A

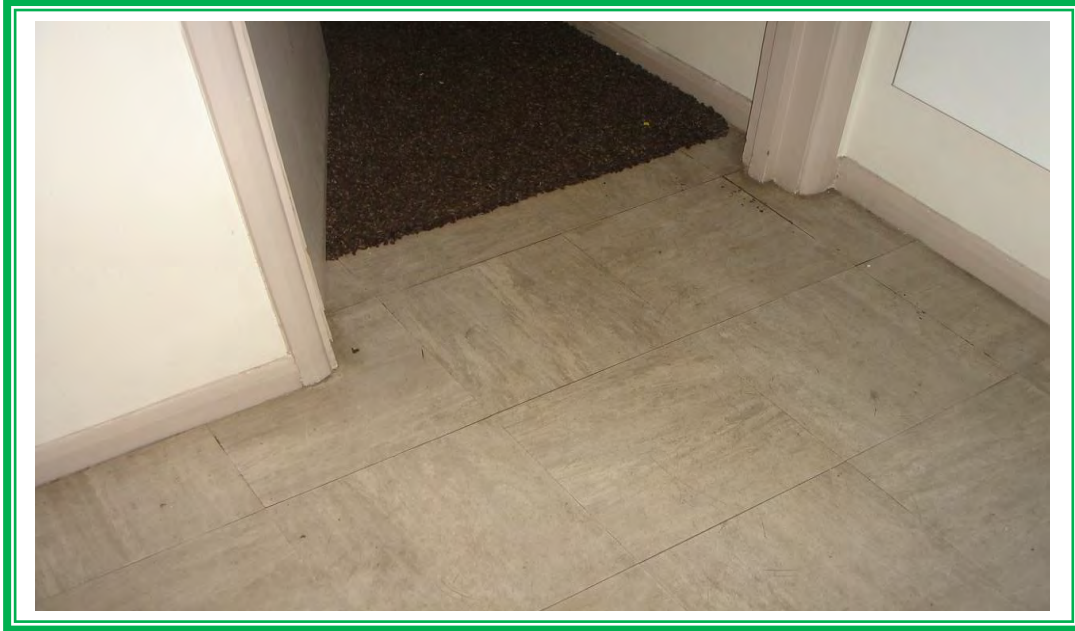
Material Description:	Vinyl Floor Tiles	
Identification:	As Per Sample NE/1- No Asbestos Detected	
Approx. quantity:	4M2	
Accessibility	N/A	Assessment Score
Product type:	N/A	N/A
Extent of Damage:	N/A	N/A
Surface Treatment:	N/A	N/A
Asbestos type:	N/A	N/A
Material Assessment Score:		N/A
Priority Assessment Score:		N/A
Action:	N/A	
Comments:	N/A

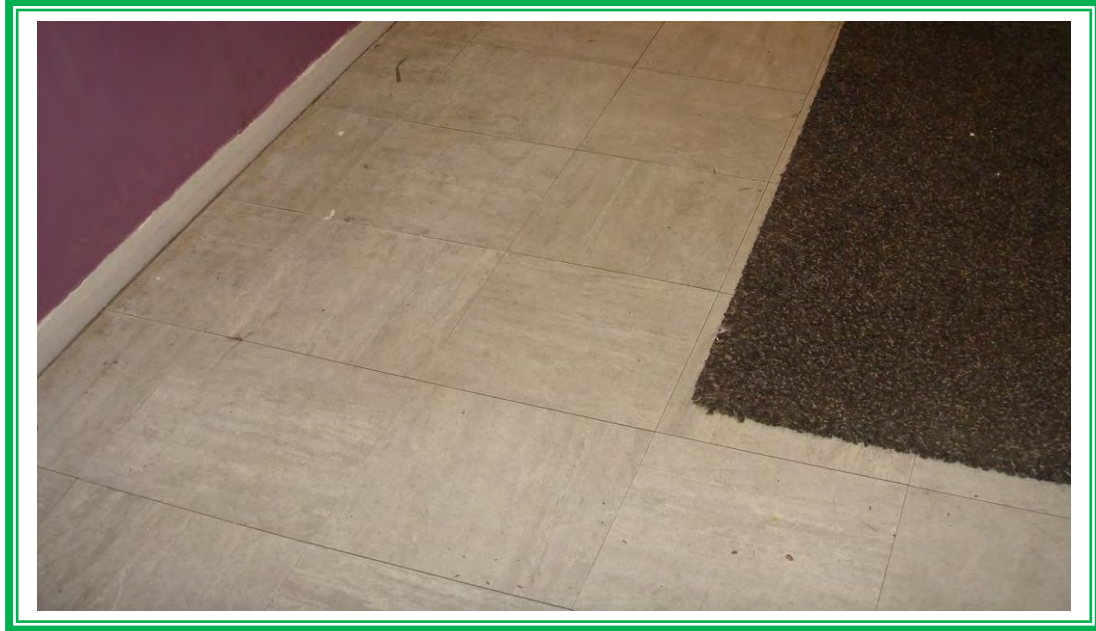
Material Description:	Vinyl Floor Tiles	
Identification:	As Per Sample NE/1- No Asbestos Detected	
Approx. quantity:	8M2	
Accessibility	N/A	Assessment Score
Product type:	N/A	N/A
Extent of Damage:	N/A	N/A
Surface Treatment:	N/A	N/A
Asbestos type:	N/A	N/A
Material Assessment Score:		N/A
Priority Assessment Score:		N/A
Action:	N/A	
Comments:	N/A

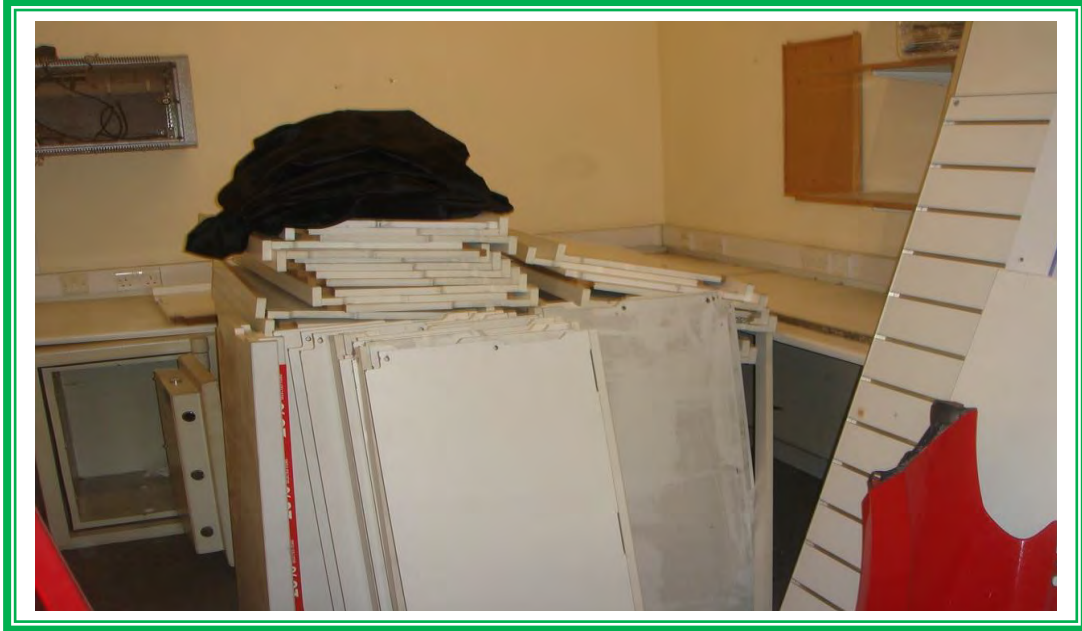
Location: 1/006 Stores

Material Description:	Visual Inspection – No Suspect Materials Found	
Identification:	N/A	
Approx. quantity:	N/A	
Accessibility	N/A	Assessment Score
Product type:	N/A	N/A
Extent of Damage:	N/A	N/A
Surface Treatment:	N/A	N/A
Asbestos type:	N/A	N/A
Material Assessment Score:		N/A
Priority Assessment Score:		N/A
Action:	N/A	
Comments:	N/A

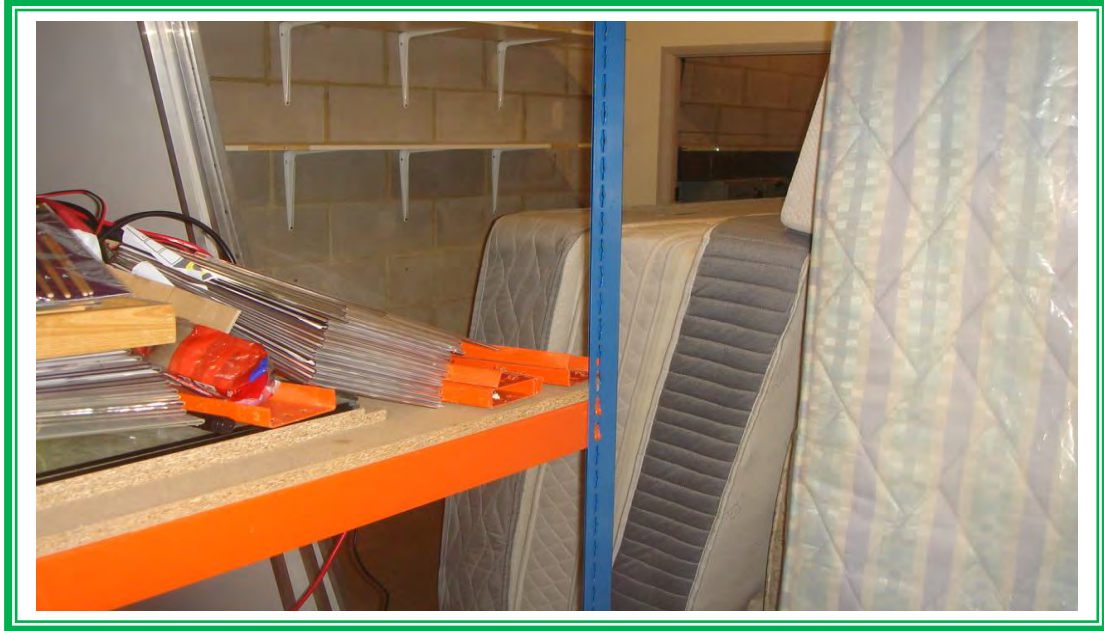
Location: 1/007 Stores

Material Description:	Visual Inspection – No Suspect Materials Found	
Identification:	N/A	
Approx. quantity:	N/A	
Accessibility	N/A	Assessment Score
Product type:	N/A	N/A
Extent of Damage:	N/A	N/A
Surface Treatment:	N/A	N/A
Asbestos type:	N/A	N/A
Material Assessment Score:		N/A
Priority Assessment Score:		N/A
Action:	N/A	
Comments:	N/A

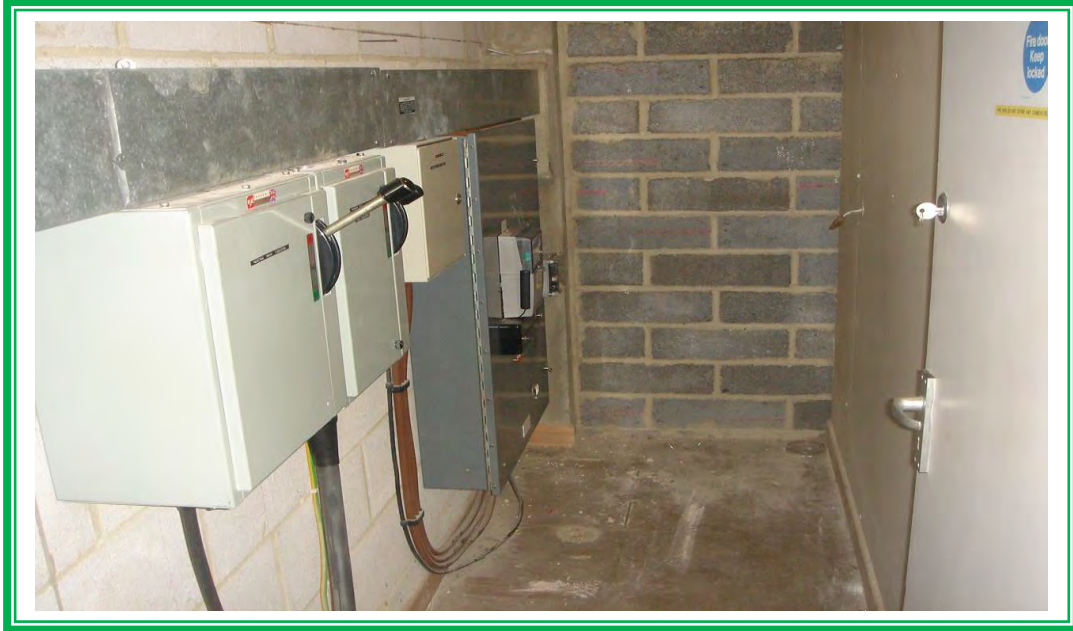
Location: 1/008 Electric Room

Material Description:	Visual Inspection – No Suspect Materials Found	
Identification:	N/A	
Approx. quantity:	N/A	
Accessibility	N/A	Assessment Score
Product type:	N/A	N/A
Extent of Damage:	N/A	N/A
Surface Treatment:	N/A	N/A
Asbestos type:	N/A	N/A
Material Assessment Score:		N/A
Priority Assessment Score:		N/A
Action:	N/A	
Comments:	N/A

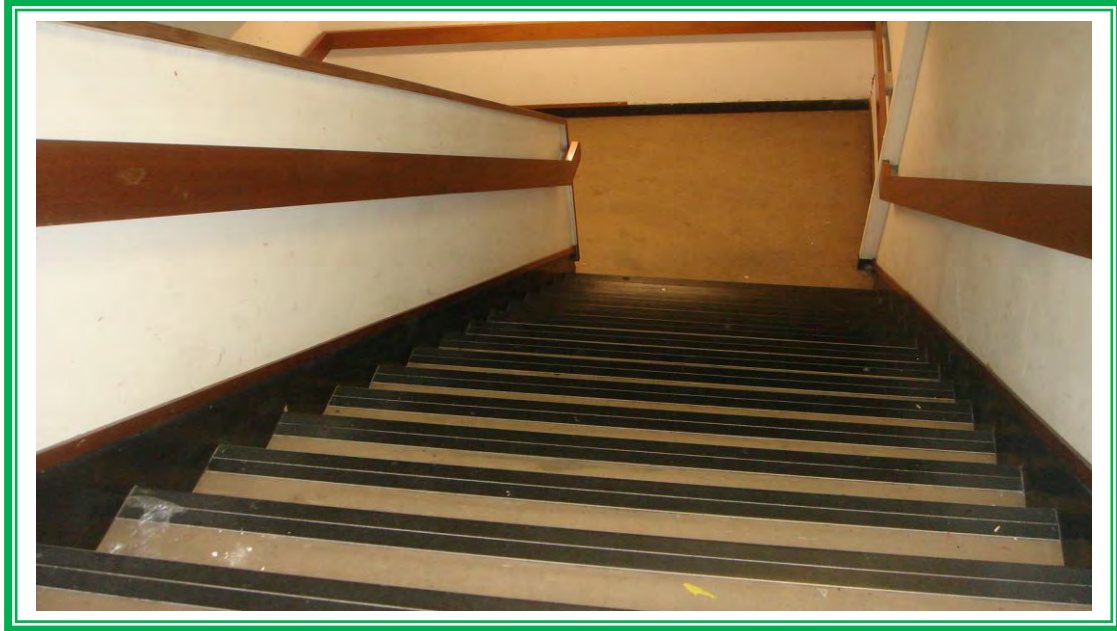
Location: 1/009 Stairs

Material Description:	Visual Inspection – No Suspect Materials Found	
Identification:	N/A	
Approx. quantity:	N/A	
Accessibility	N/A	Assessment Score
Product type:	N/A	N/A
Extent of Damage:	N/A	N/A
Surface Treatment:	N/A	N/A
Asbestos type:	N/A	N/A
Material Assessment Score:		N/A
Priority Assessment Score:		N/A
Action:	N/A	
Comments:	N/A

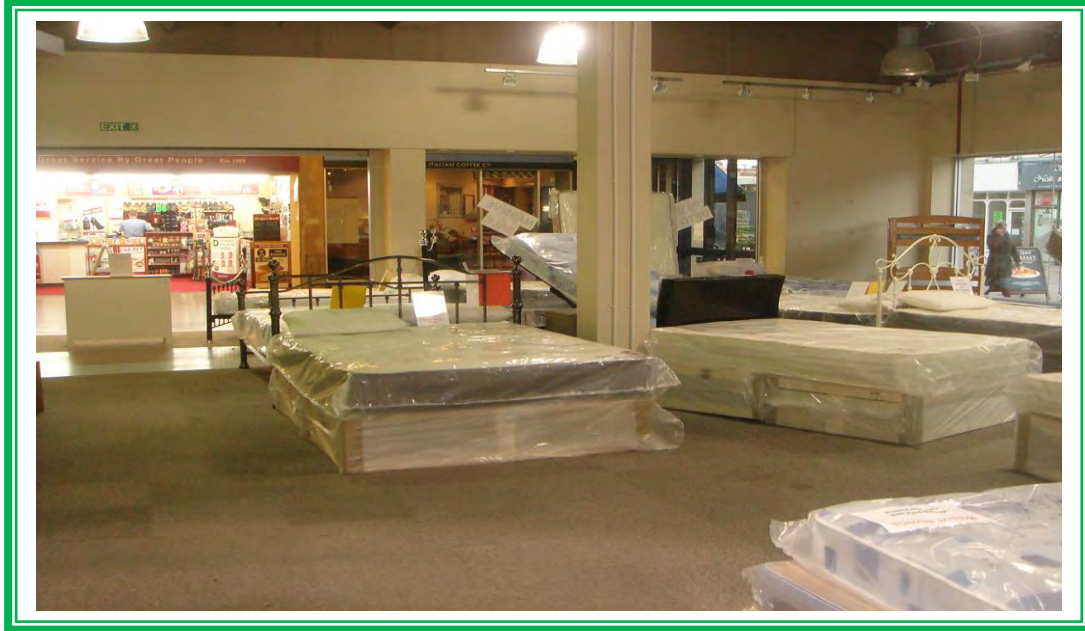
Location: 0/001 Shop Floor

Material Description:	Visual Inspection – No Suspect Materials Found	
Identification:	N/A	
Approx. quantity:	N/A	
Accessibility	N/A	Assessment Score
Product type:	N/A	N/A
Extent of Damage:	N/A	N/A
Surface Treatment:	N/A	N/A
Asbestos type:	N/A	N/A
Material Assessment Score:		N/A
Priority Assessment Score:		N/A
Action:	N/A	
Comments:	N/A

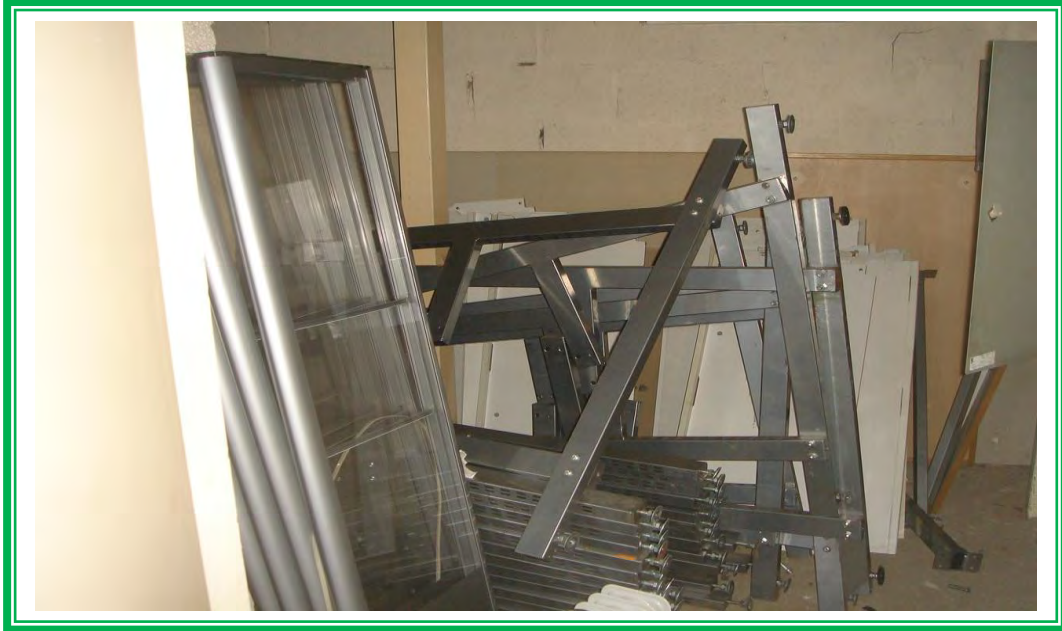
Location: 0/003 Cupboard

Material Description:	Visual Inspection – No Suspect Materials Found	
Identification:	N/A	
Approx. quantity:	N/A	
Accessibility	N/A	Assessment Score
Product type:	N/A	N/A
Extent of Damage:	N/A	N/A
Surface Treatment:	N/A	N/A
Asbestos type:	N/A	N/A
Material Assessment Score:		N/A
Priority Assessment Score:		N/A
Action:	N/A	
Comments:	N/A

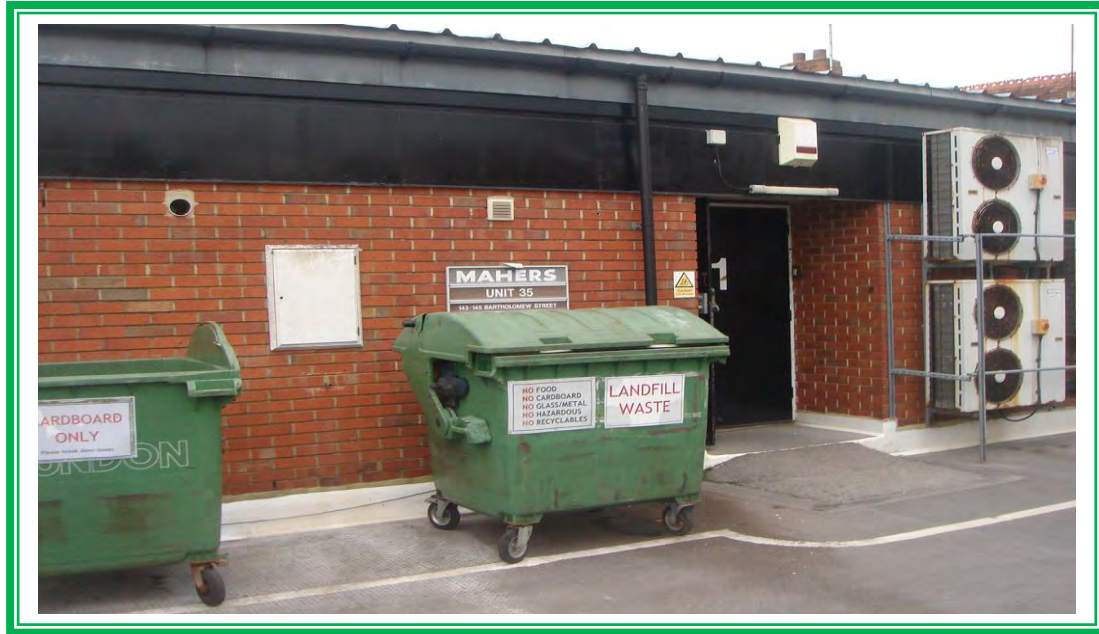
Location: 99/001 External

Material Description:	Visual Inspection – No Suspect Materials Found	
Identification:	N/A	
Approx. quantity:	N/A	
Accessibility	N/A	Assessment Score
Product type:	N/A	N/A
Extent of Damage:	N/A	N/A
Surface Treatment:	N/A	N/A
Asbestos type:	N/A	N/A
Material Assessment Score:		N/A
Priority Assessment Score:		N/A
Action:	N/A	
Comments:	N/A
